Appendix 3
Photographic Record _ Heritage Attributes _ 1217 Fourth Line

Physical Attributes

- Massing of the one storey brick Italianate-style house with stone veneer on new concrete foundation

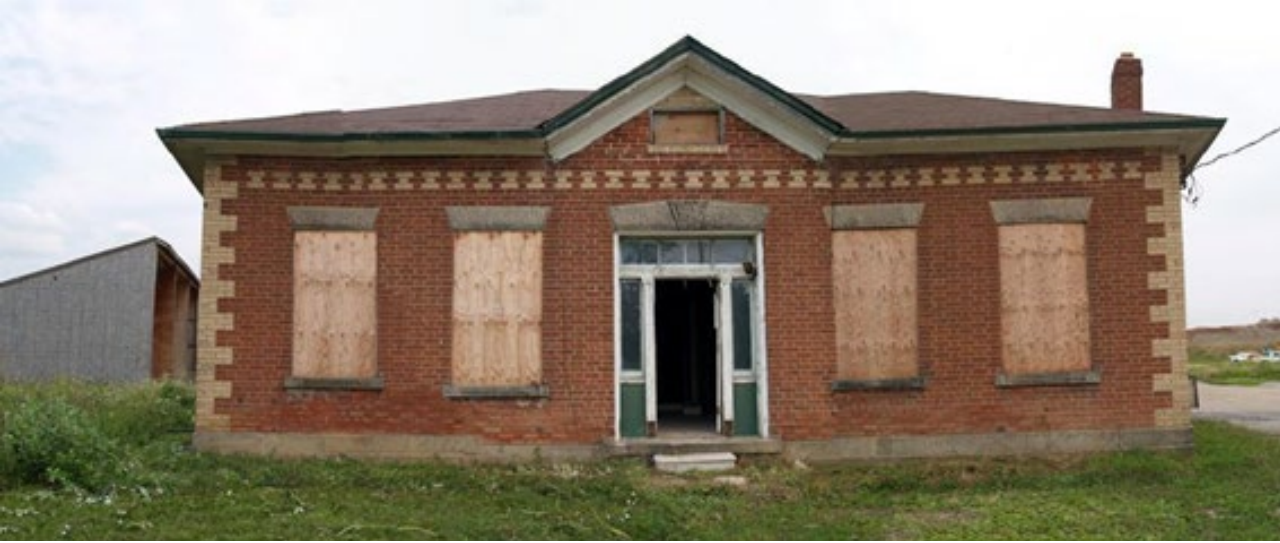
West **Before** Rehabilitation

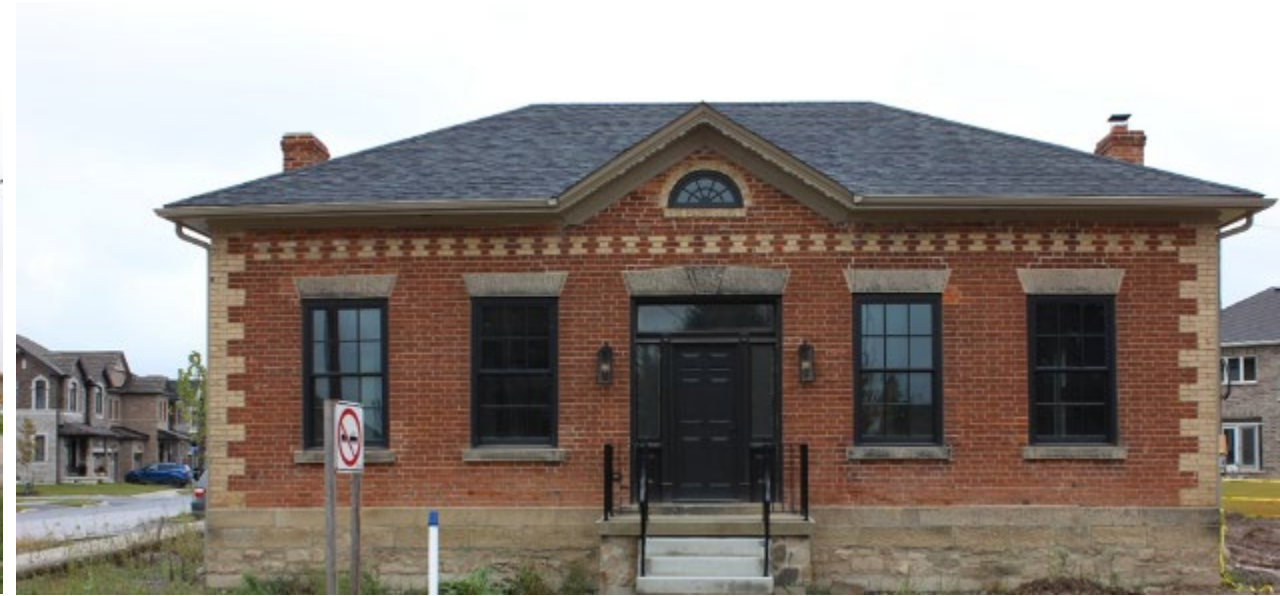
West Façade **After** Rehabilitation

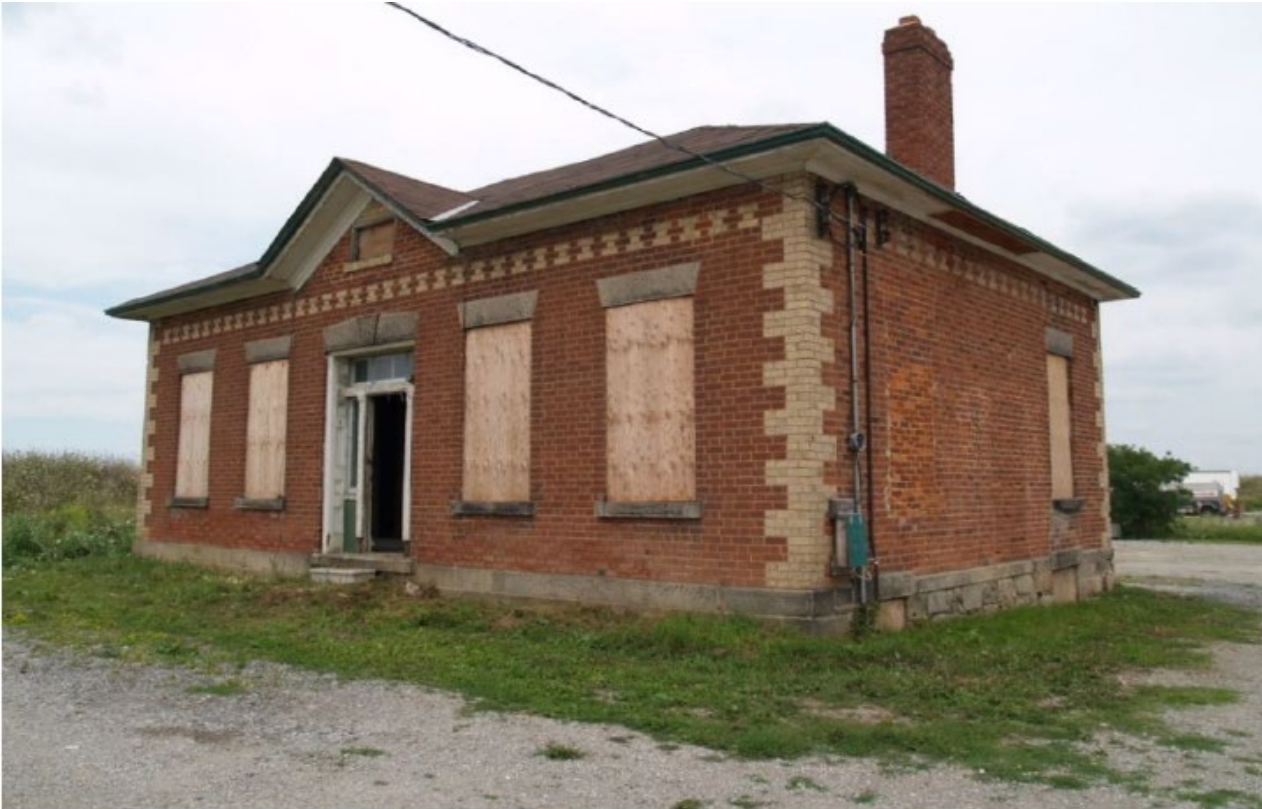
Low hipped roof with protruding eaves and central gable

West and South Façade **Before** Rehabilitation

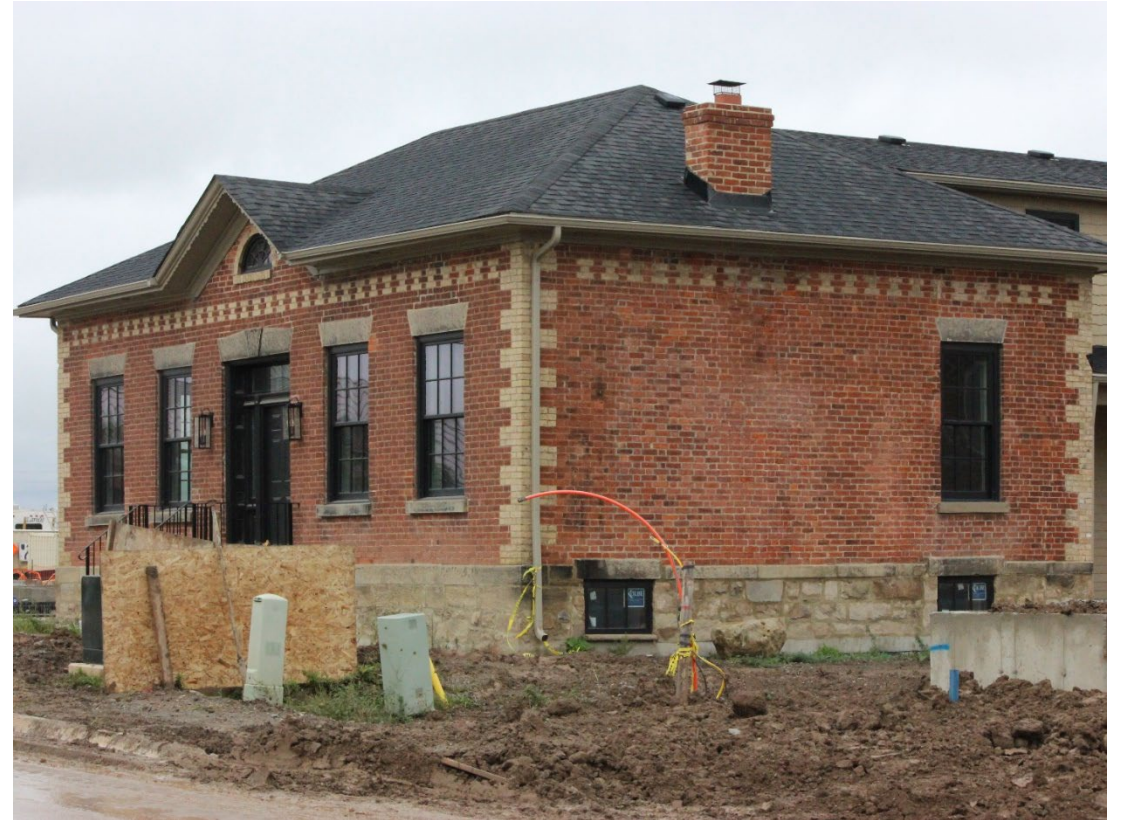
West and South Façade **After** Rehabilitation

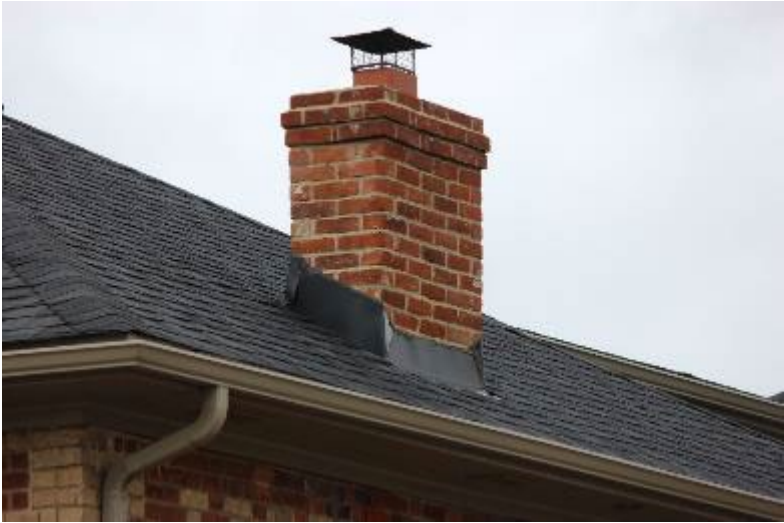
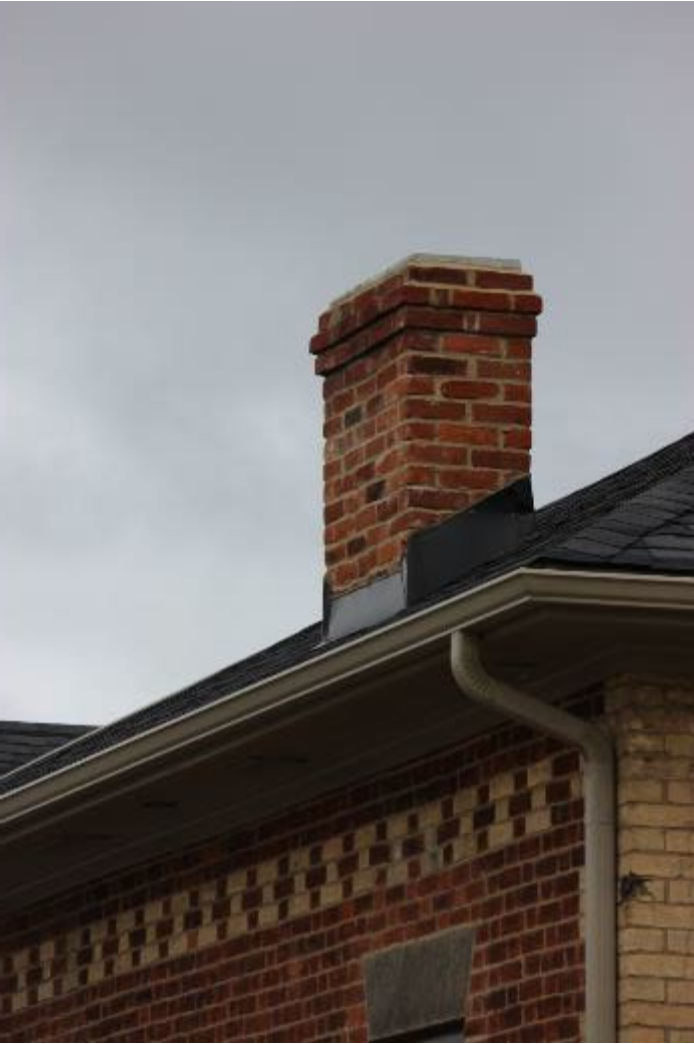
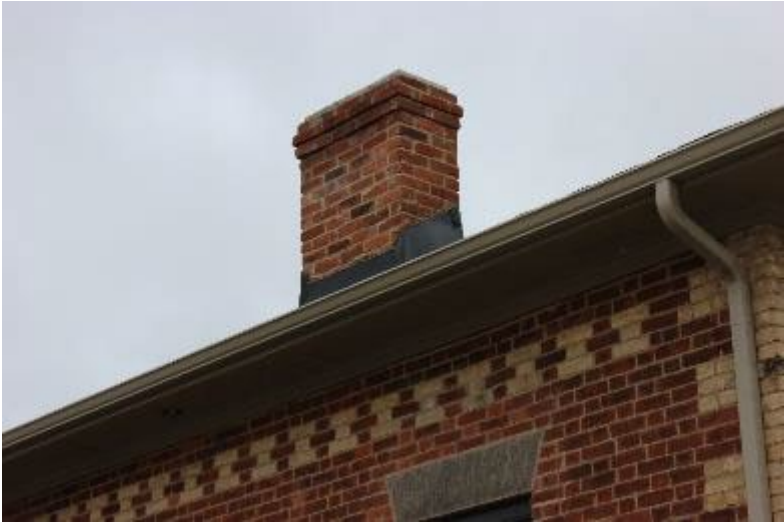
The North and South chimneys of the house were rebuilt to their original style

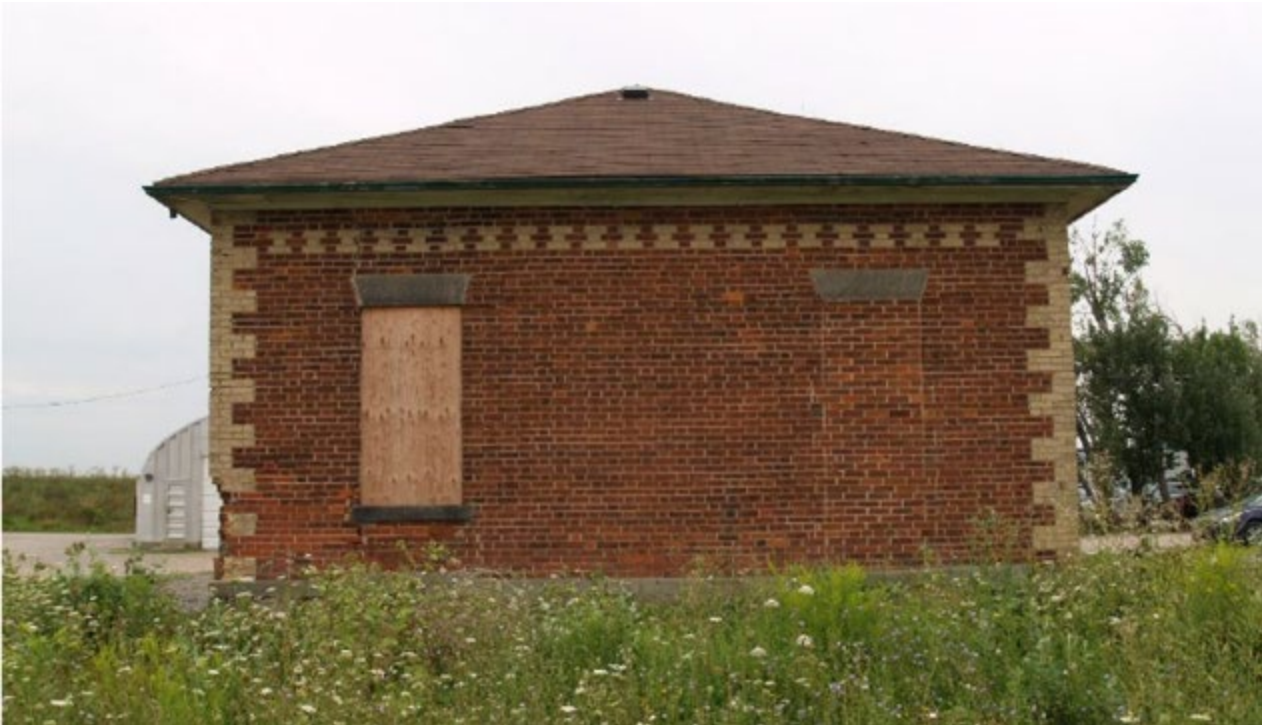
Exterior Flemish bond masonry with buff brick quoins and dichromatic string course

North Façade **Before** Rehabilitation

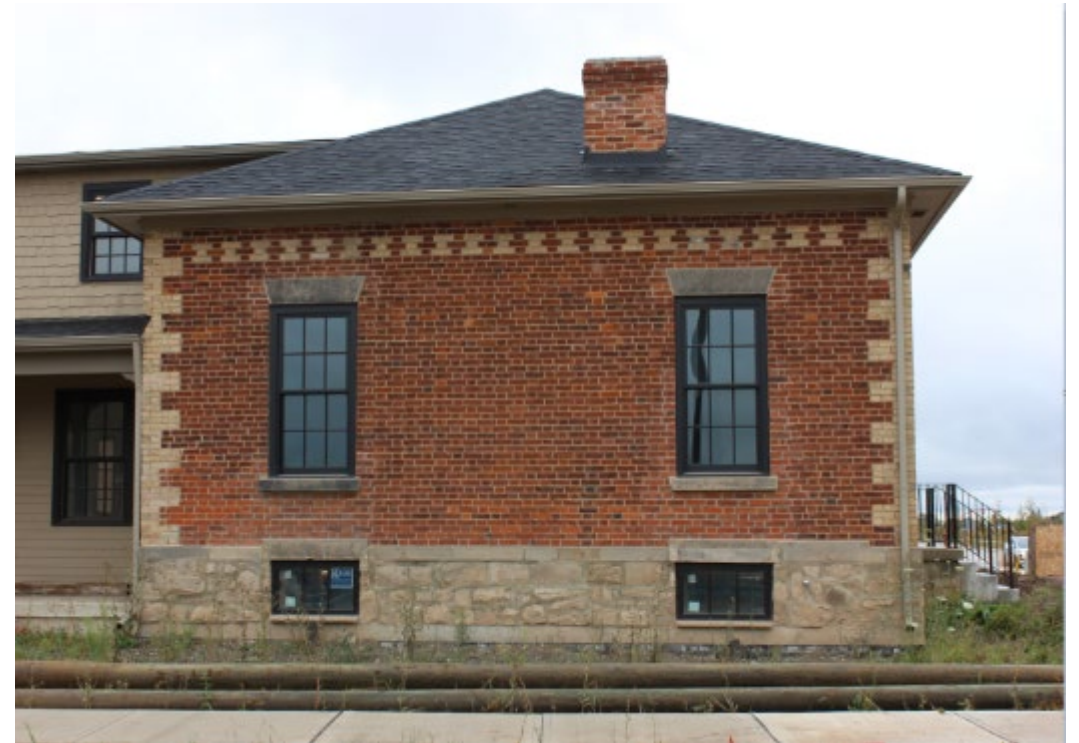
North Façade **After** Rehabilitation

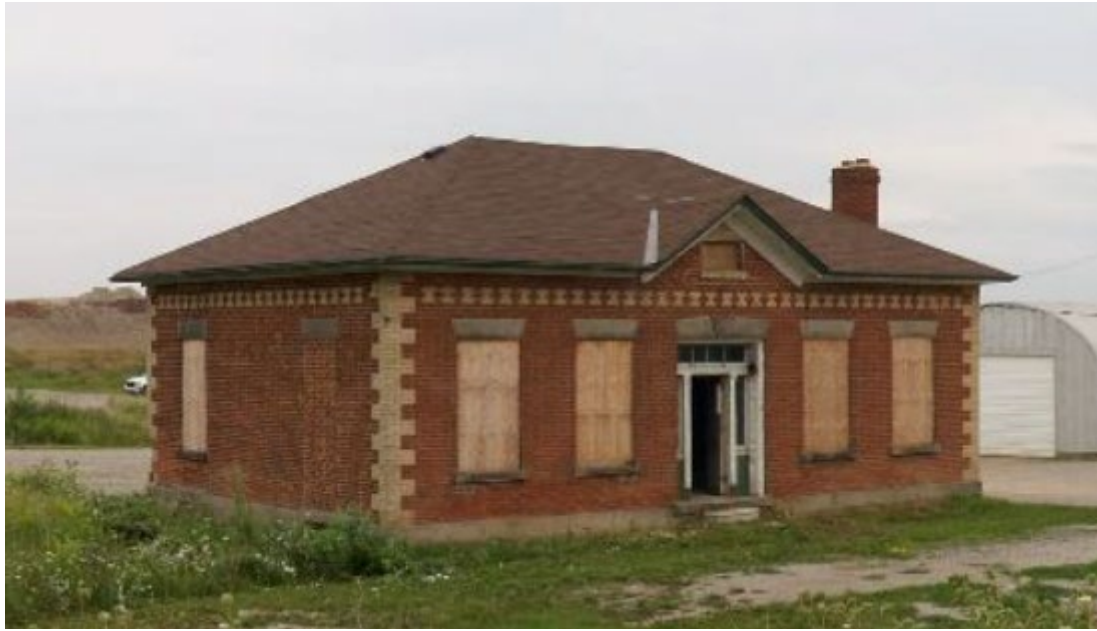
Exterior Flemish bond masonry with buff brick quoins and dichromatic string course

North East Façade **Before** Rehabilitation

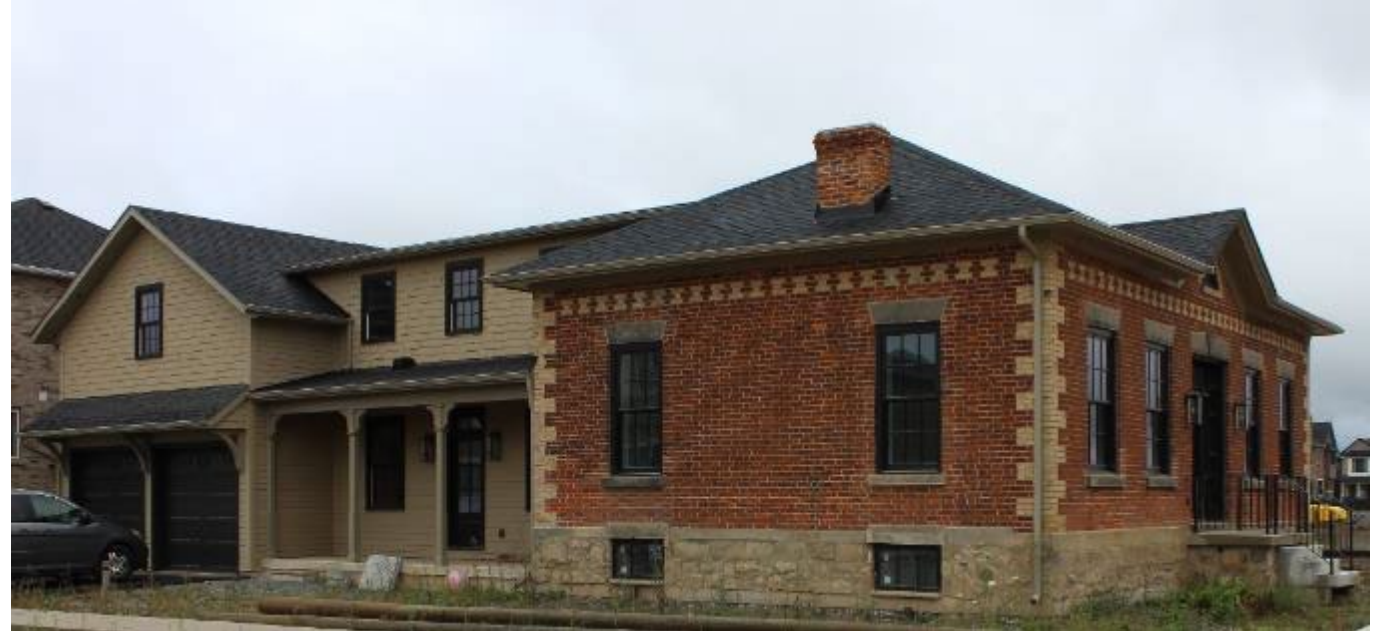
North East Façade **After** Rehabilitation

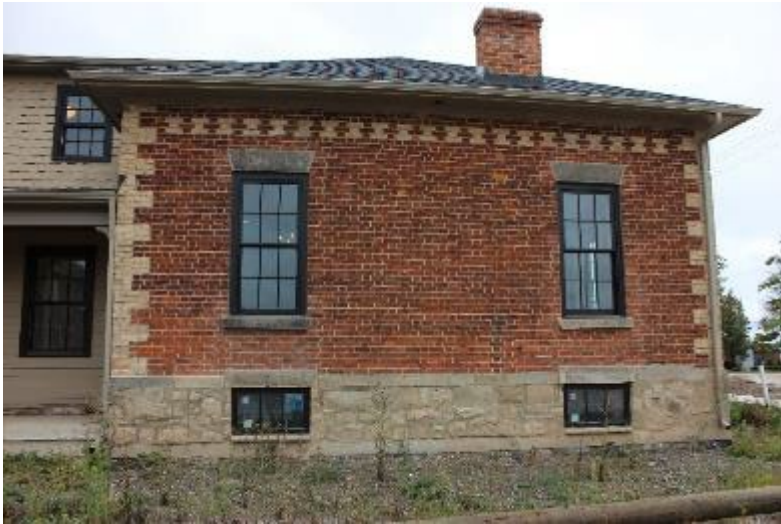
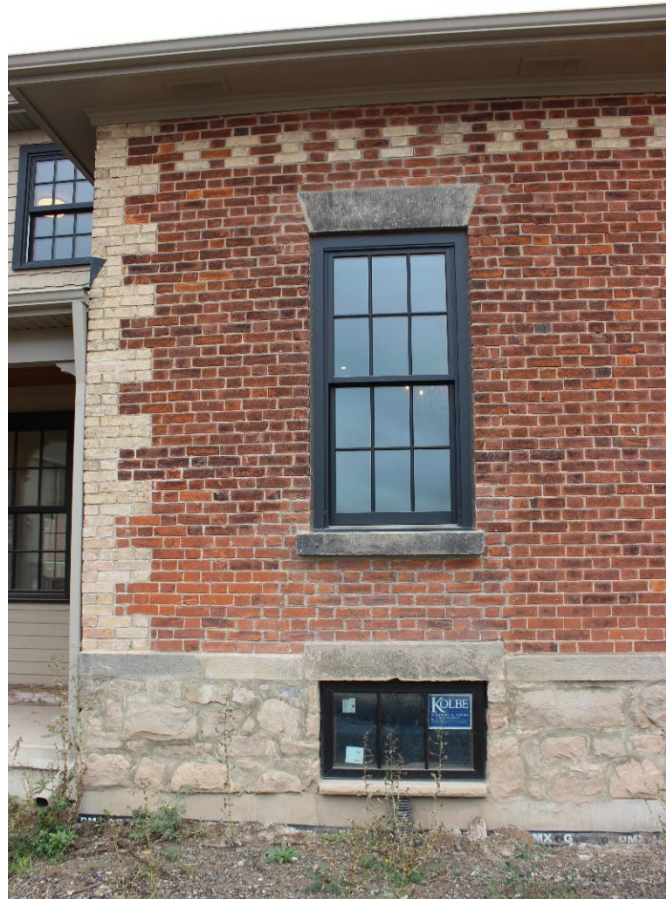
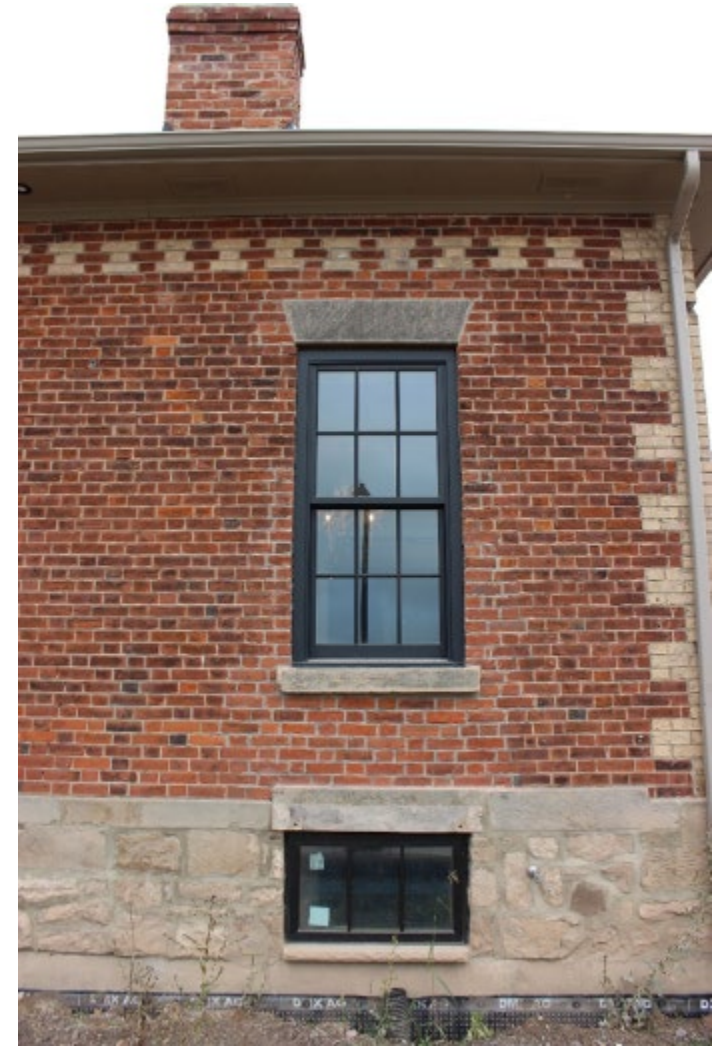
Windows at North Facade

Six over six flat windows with plain trim, stone headers and lug sills

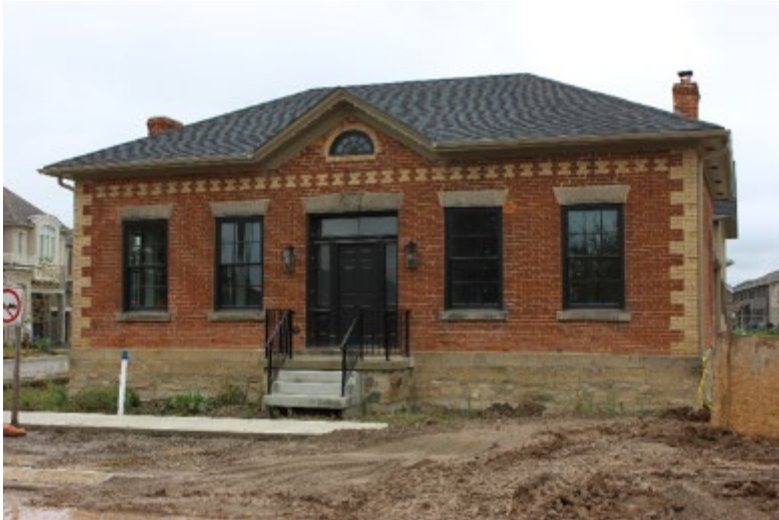
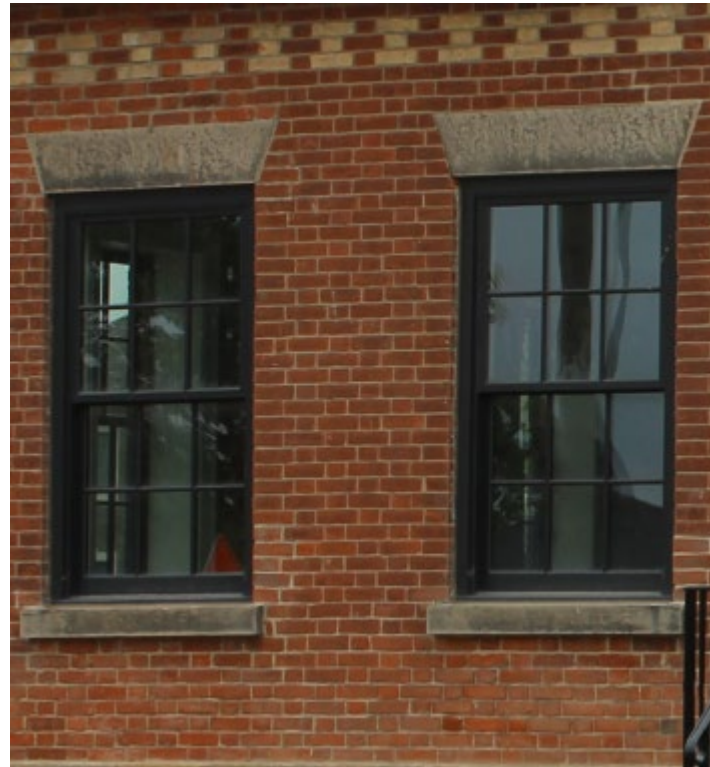
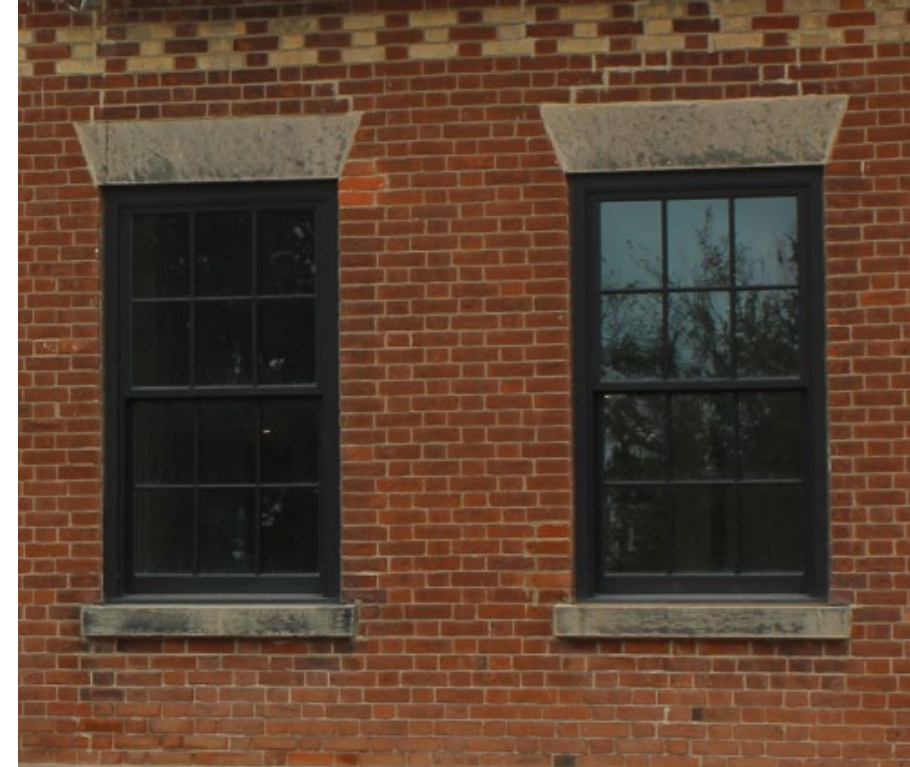
Windows at West Facade

Six over six flat windows with plain trim, stone headers and lug sills

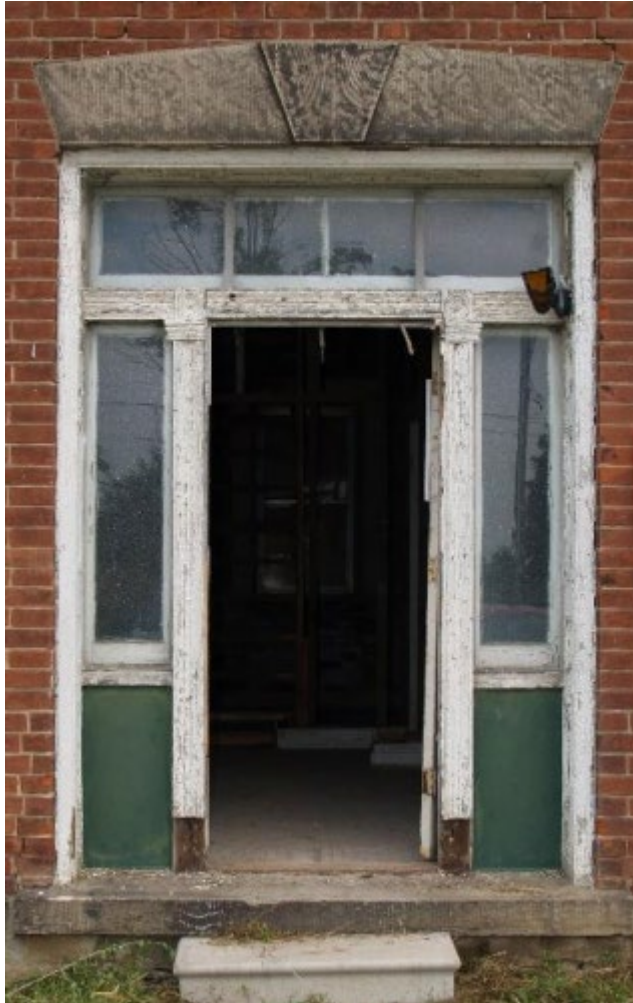
- Wide entrance with a six panel front door, transom and side lights

Prior to restoration

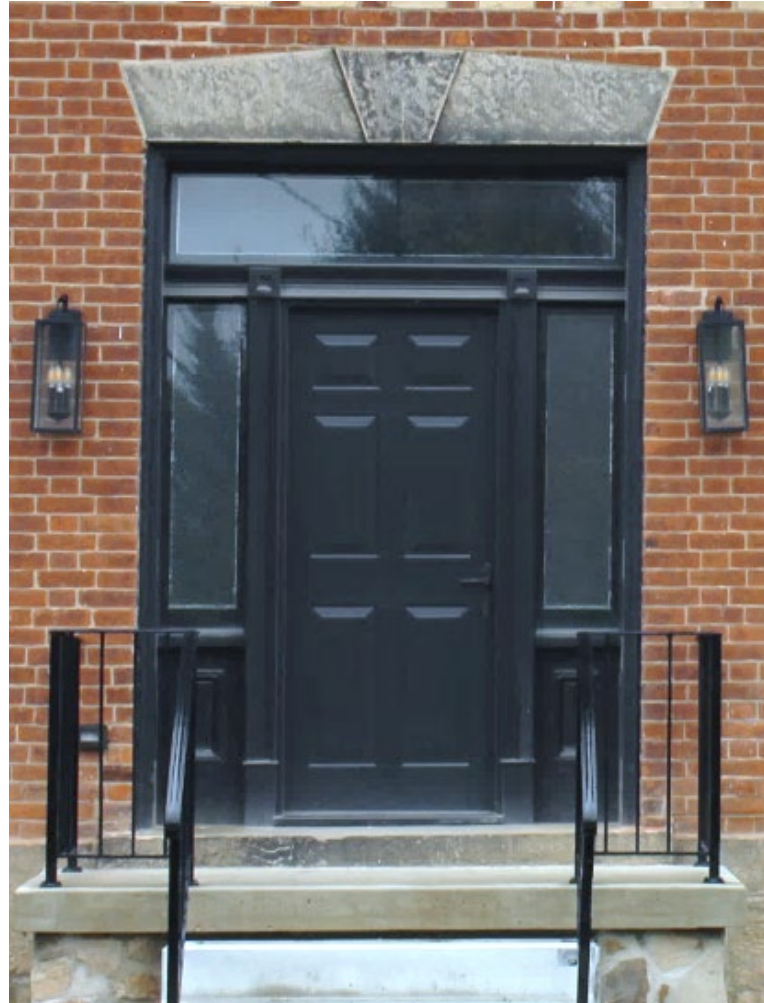
Restored Front Door Exterior

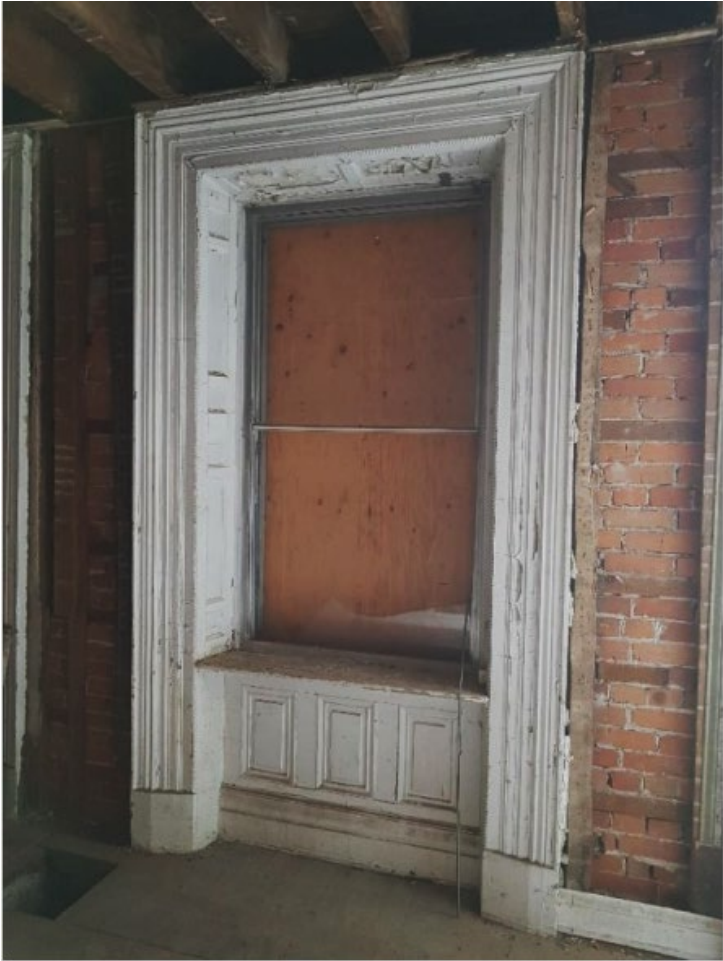
Decorative interior window casings with medallions in the original living room

Prior to restoration

* The windows of the original house were replaced with Heritage Series Kolbe wood windows

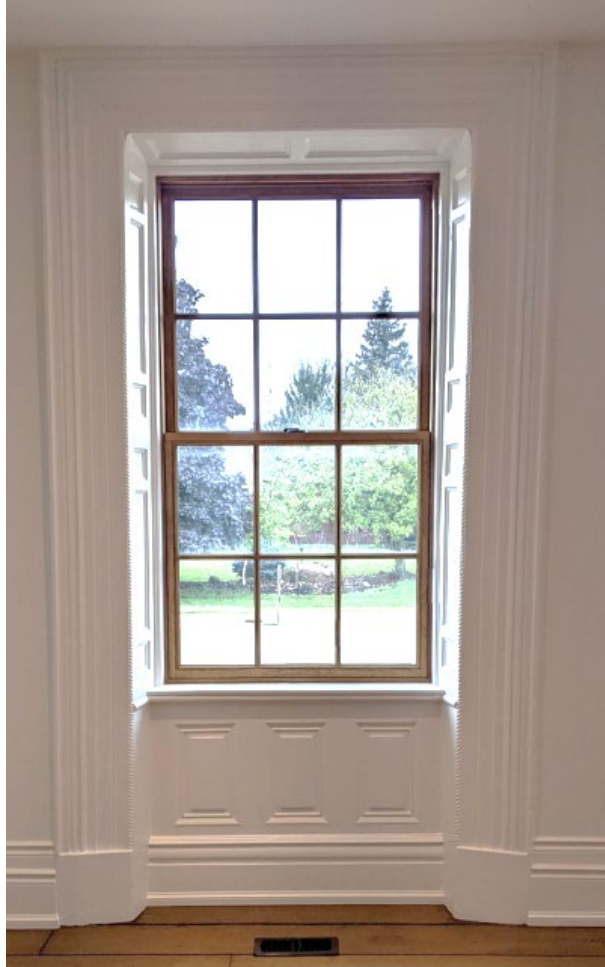
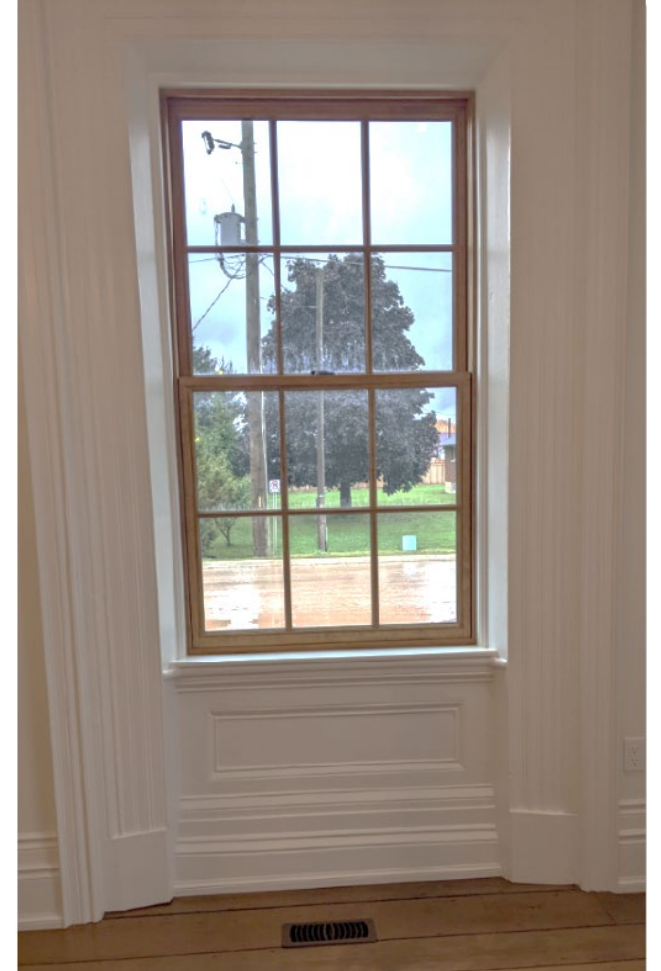
Replaced Window

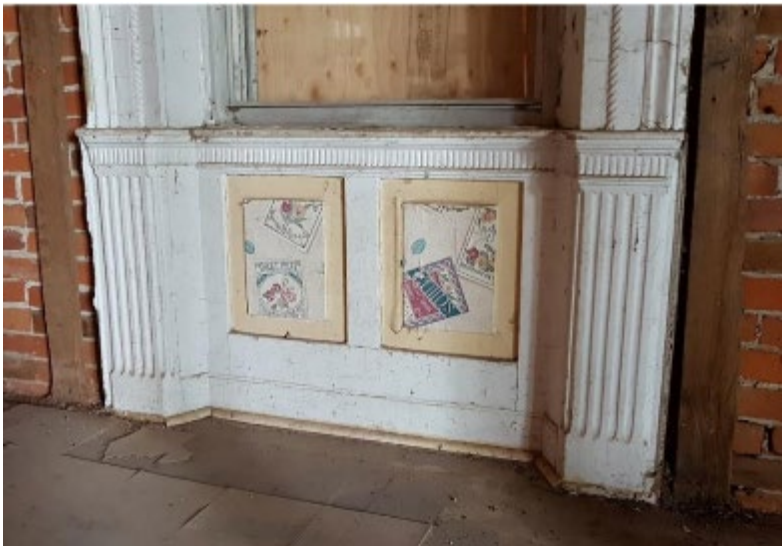
Interior window casings with medallions in the original living room

Prior to restoration

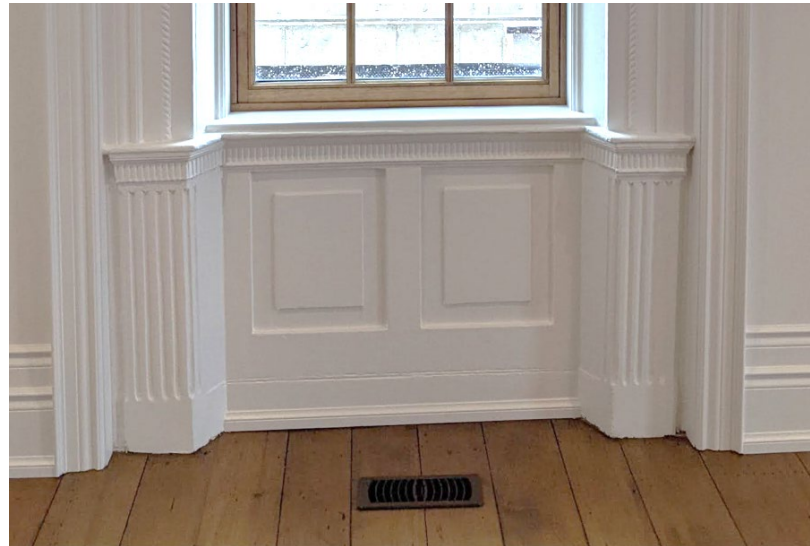
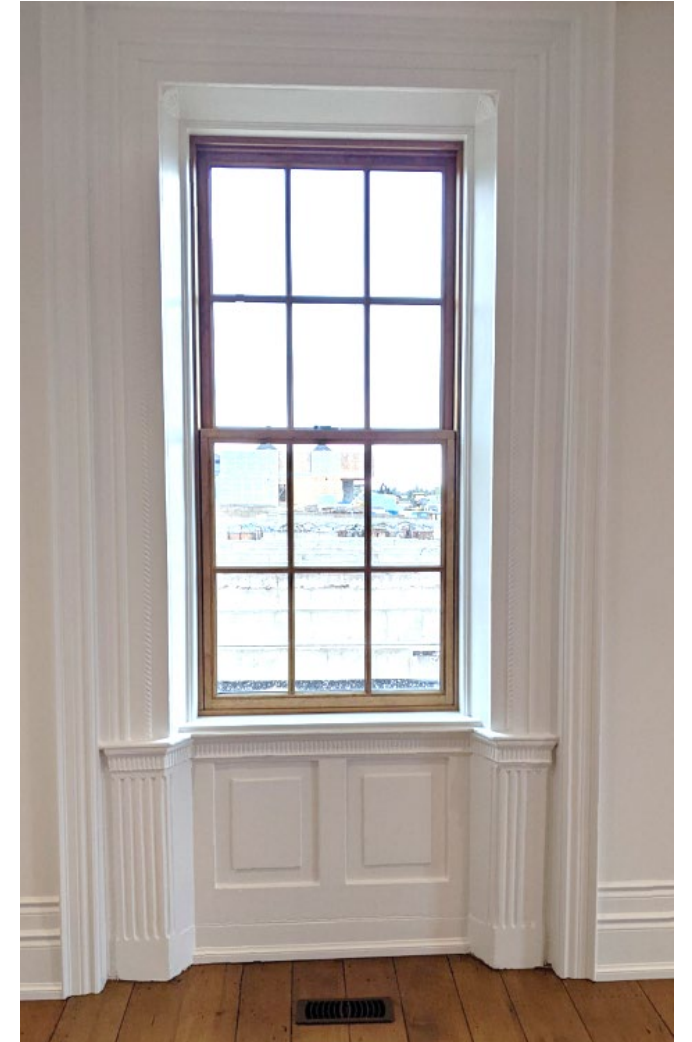
Restored Window Casing

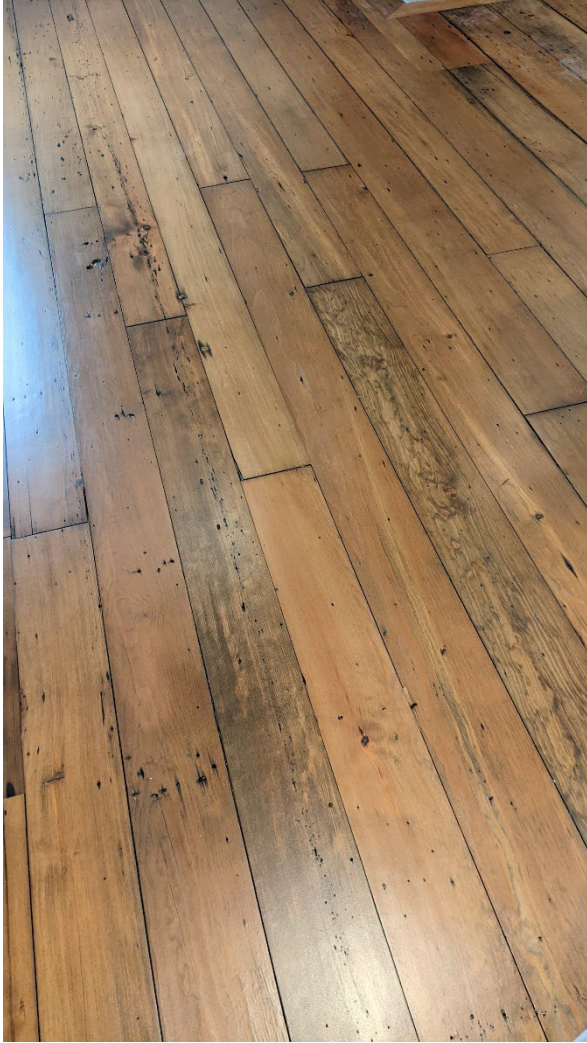
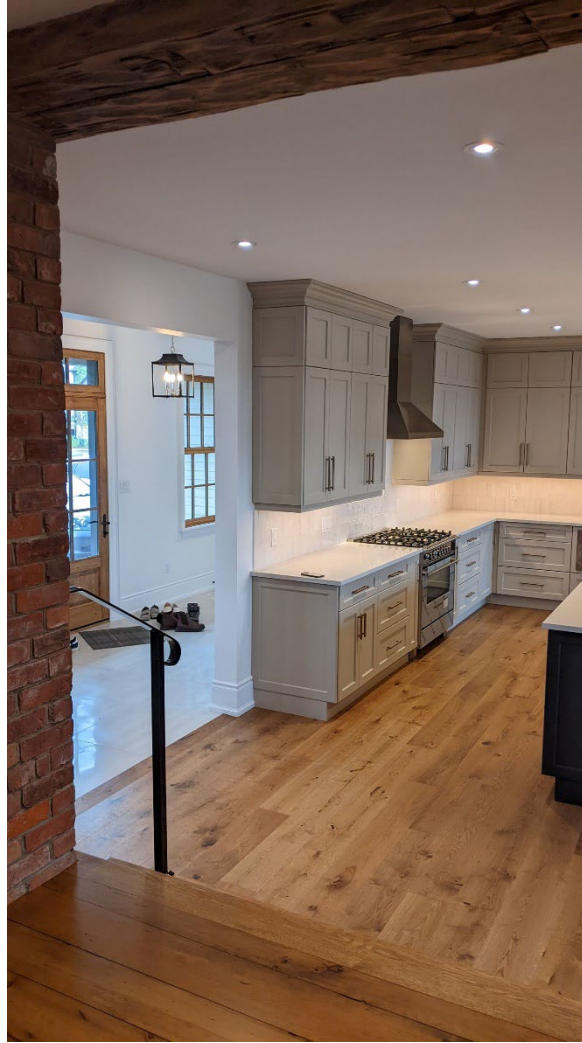
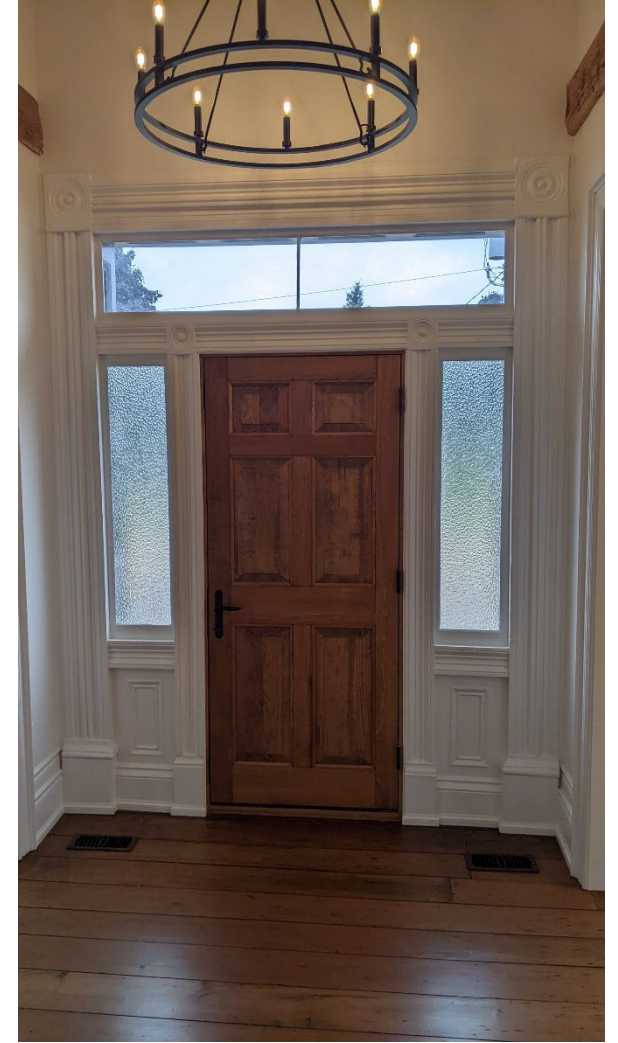
Original Pine Wood Flooring

Restored Flooring

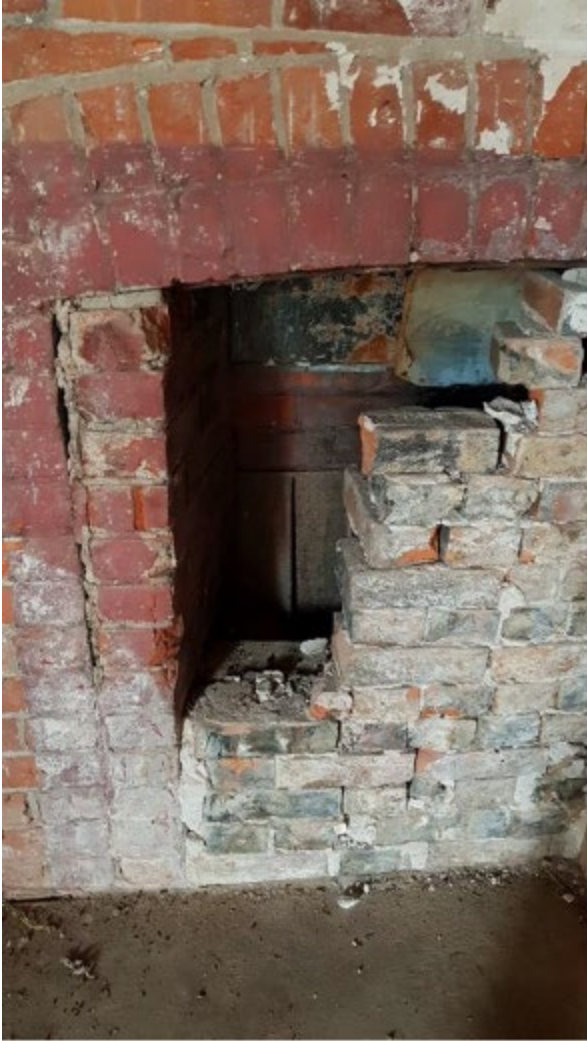
Two Brick Fireplaces

Prior to restoration Fireplace 1

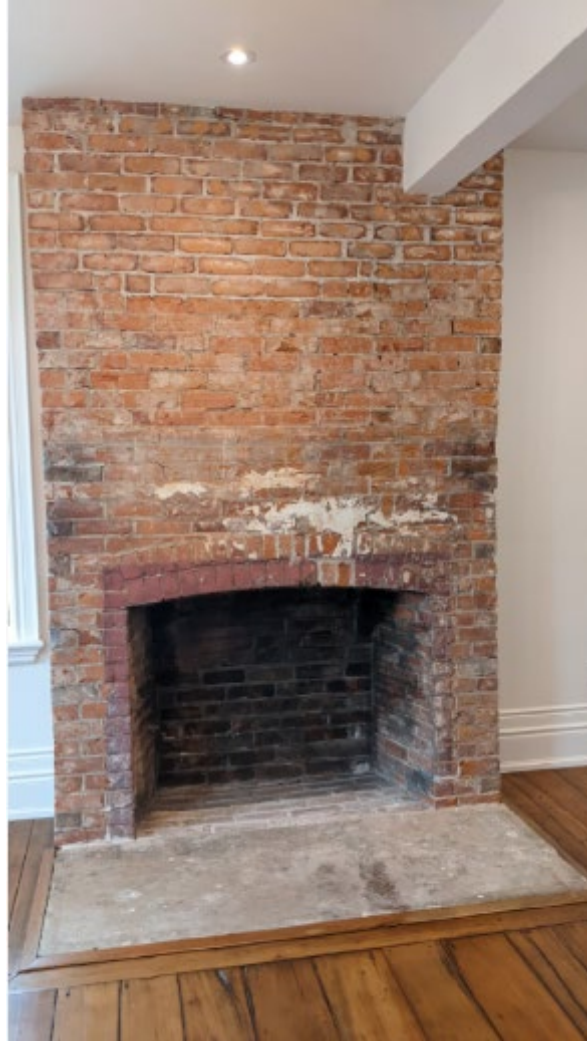
Restored Fireplace 1

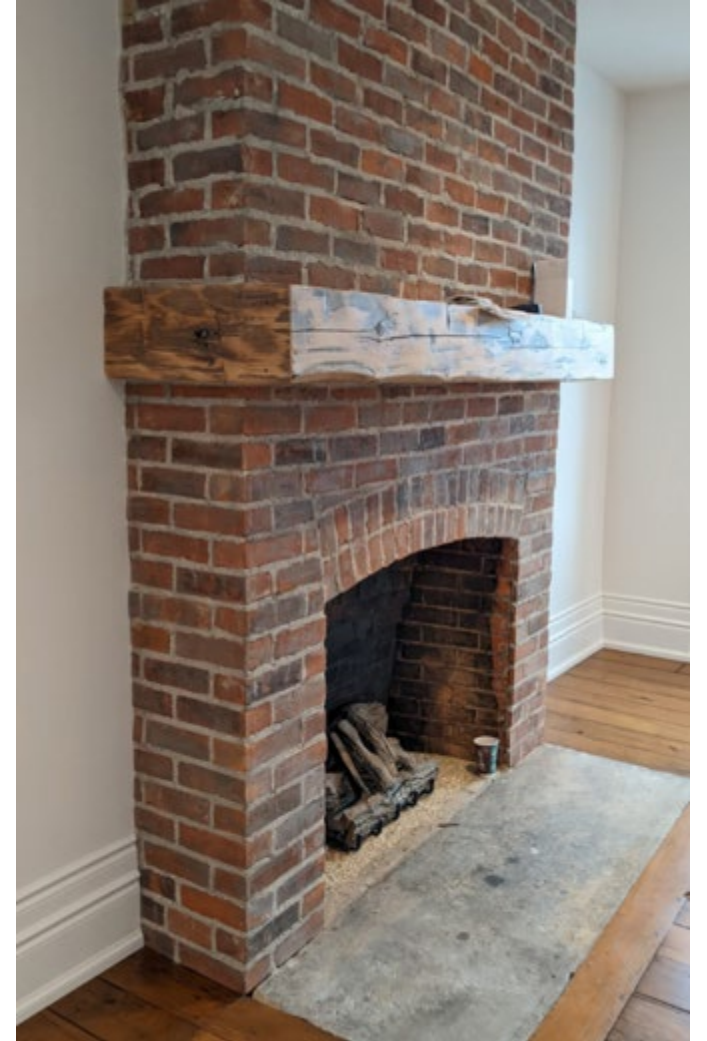
Restored Fireplace 2

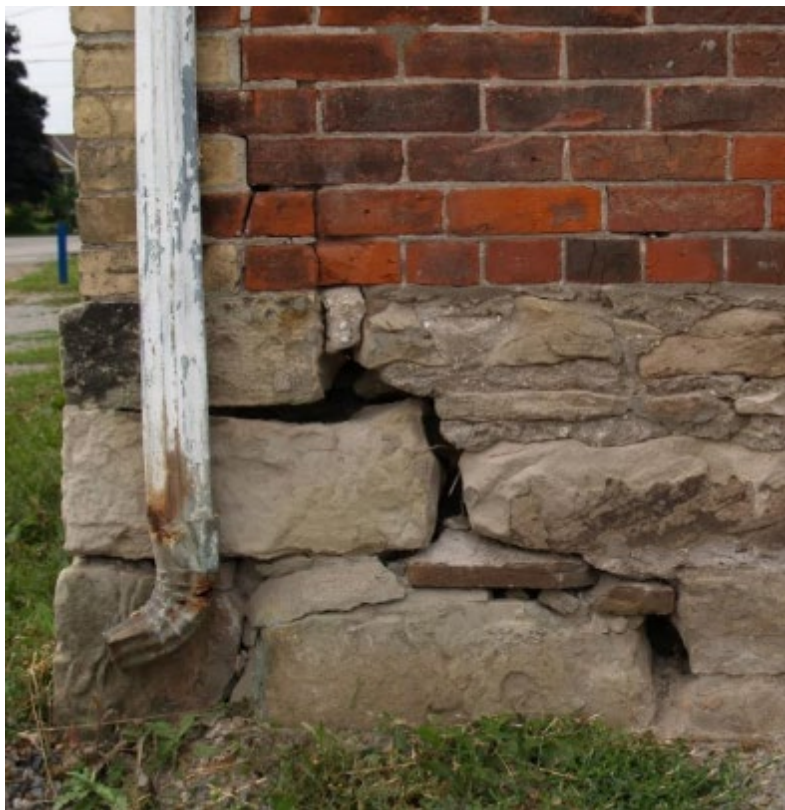
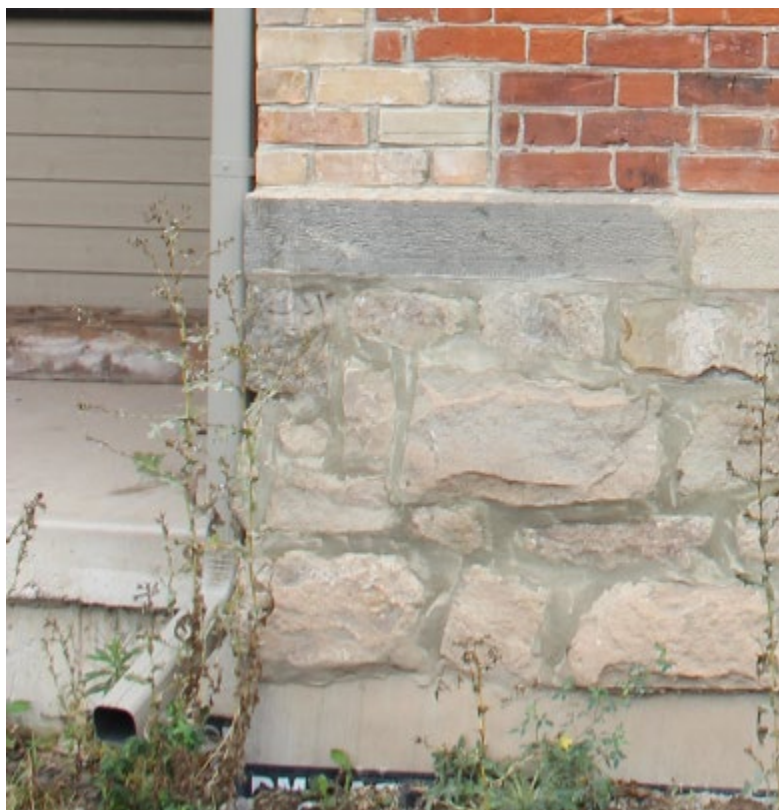
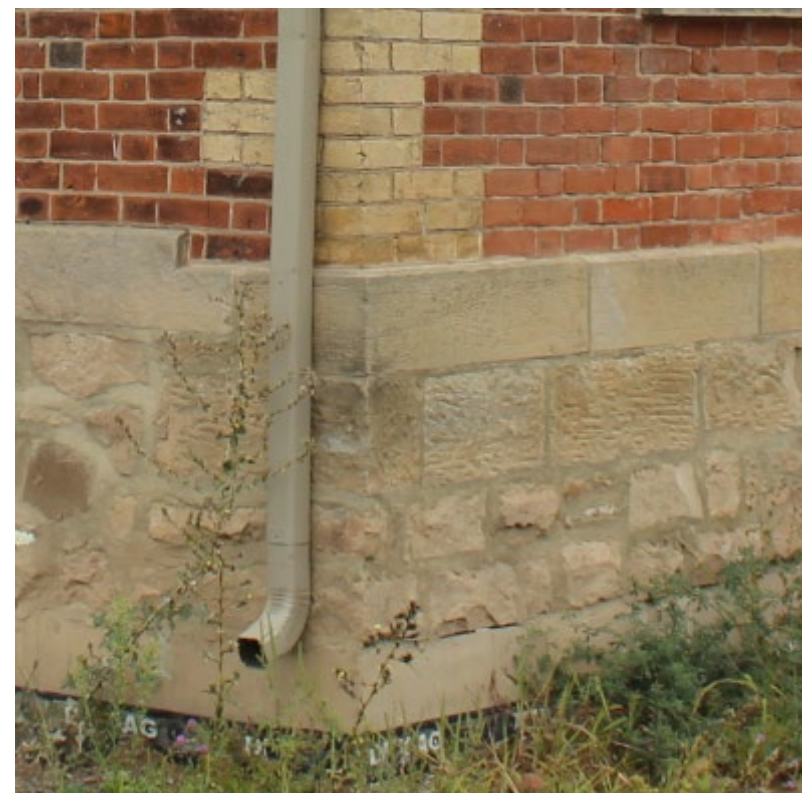
Restored exterior brick wall and rehabilitated stone veneer on concrete foundation

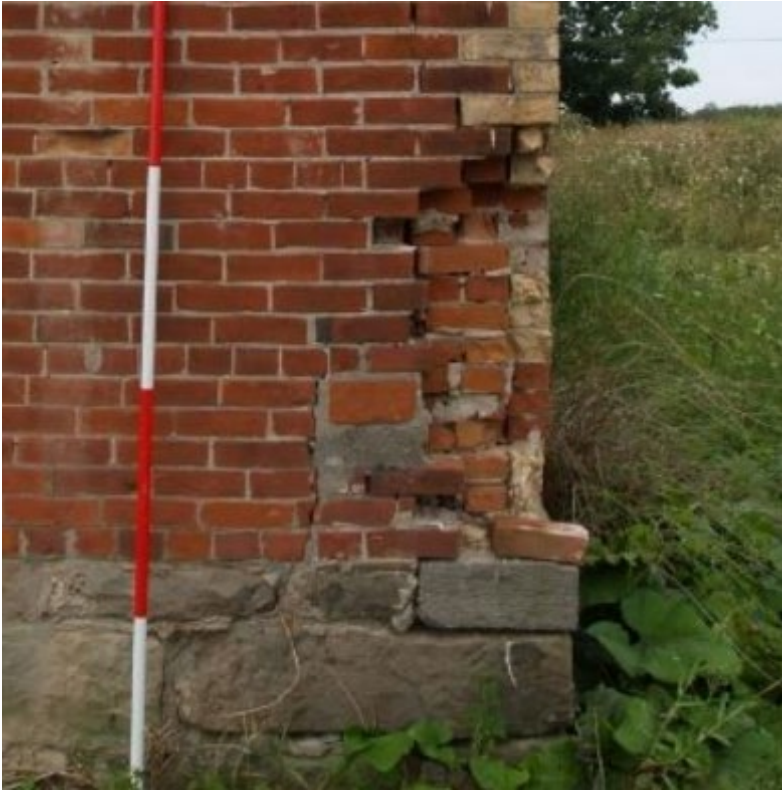
Restored exterior brick wall and rehabilitated stone veneer on concrete foundation

Before
