Appendix 3
Photographic Record _ Heritage Attributes _ 1217 Fourth Line

Physical Attributes

- Massing of the one storey brick Italianate-style house with stone veneer on new concrete foundation

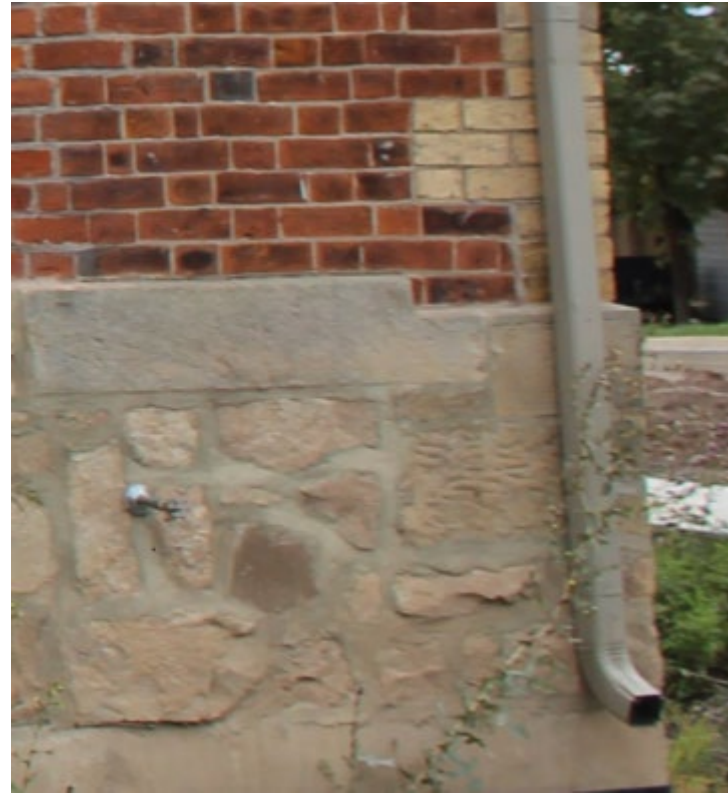
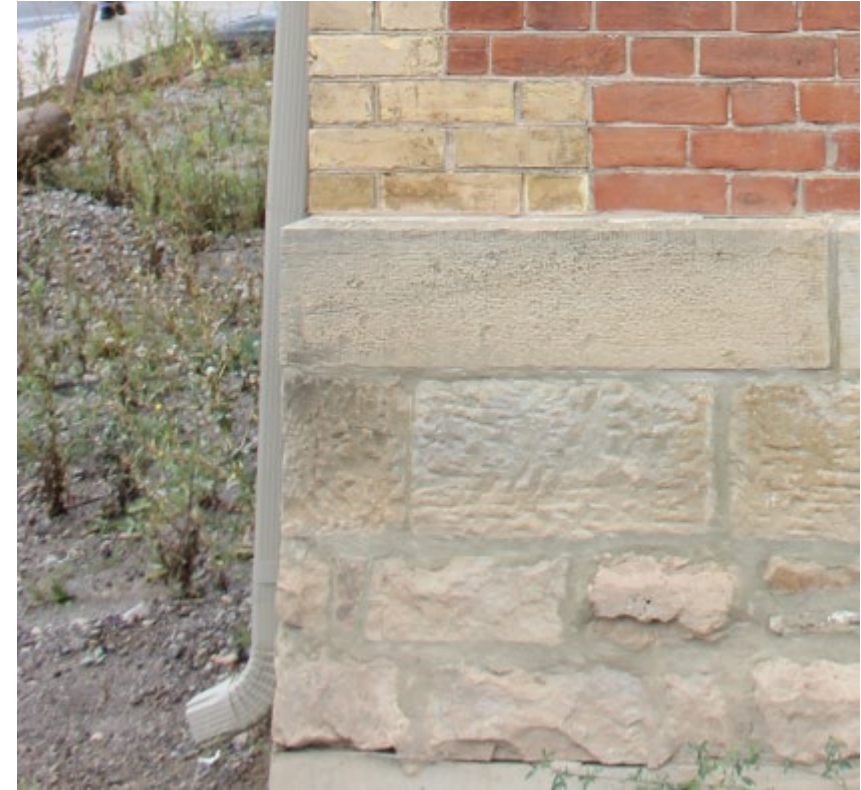
After

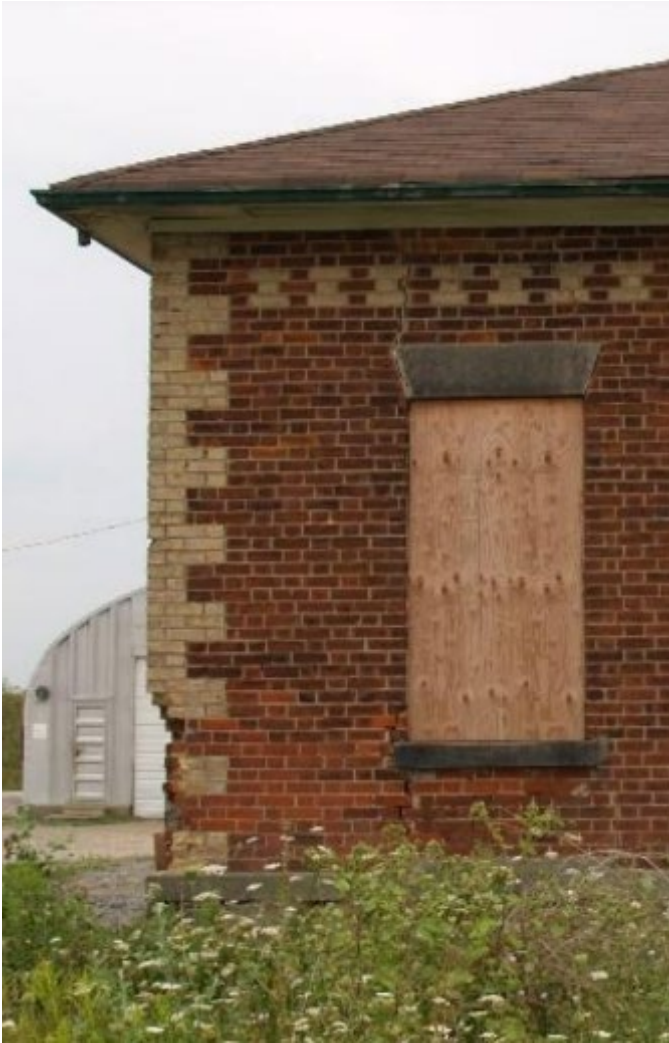
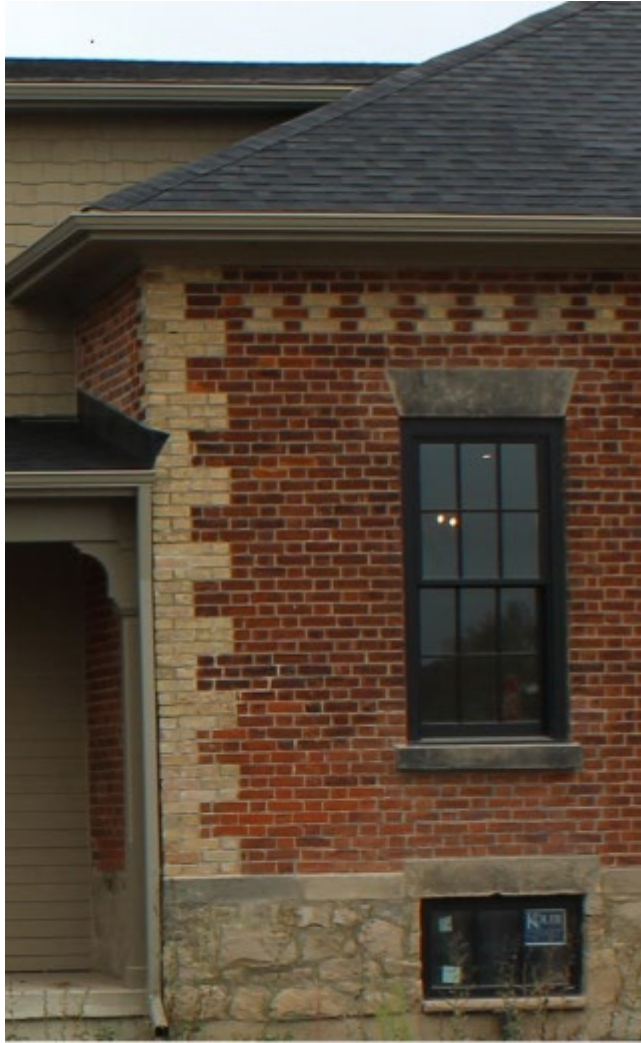
Physical Attributes
Restored brick wall and windows

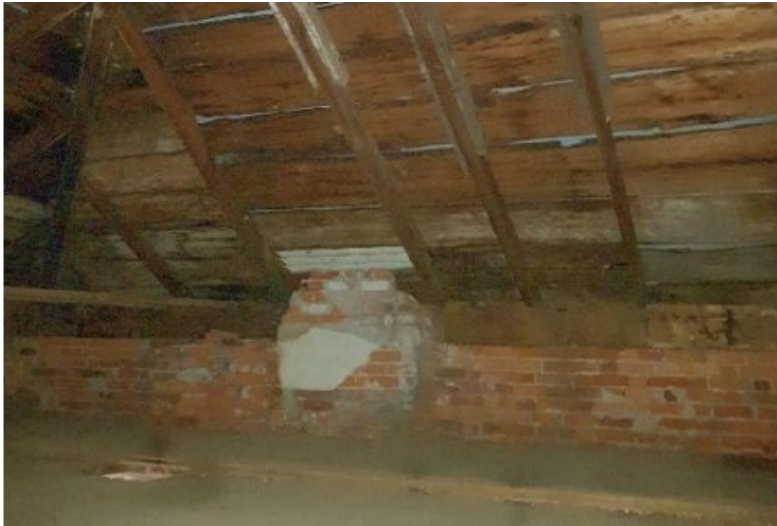
Condition of Attic prior to rehabilitation

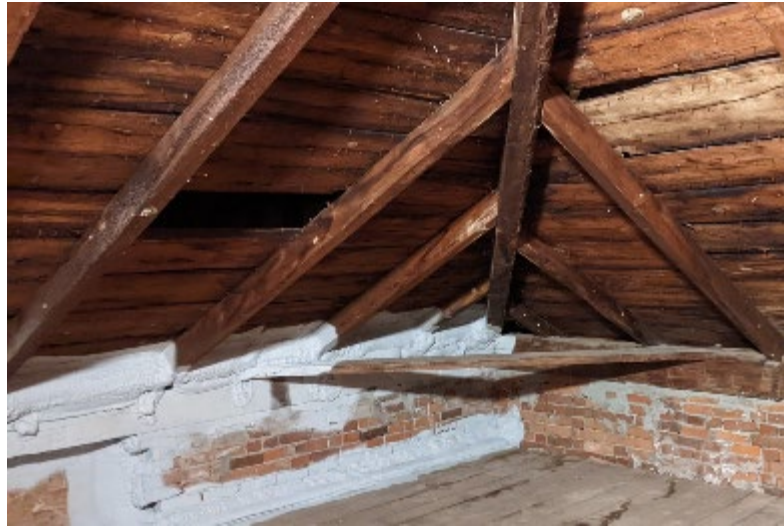
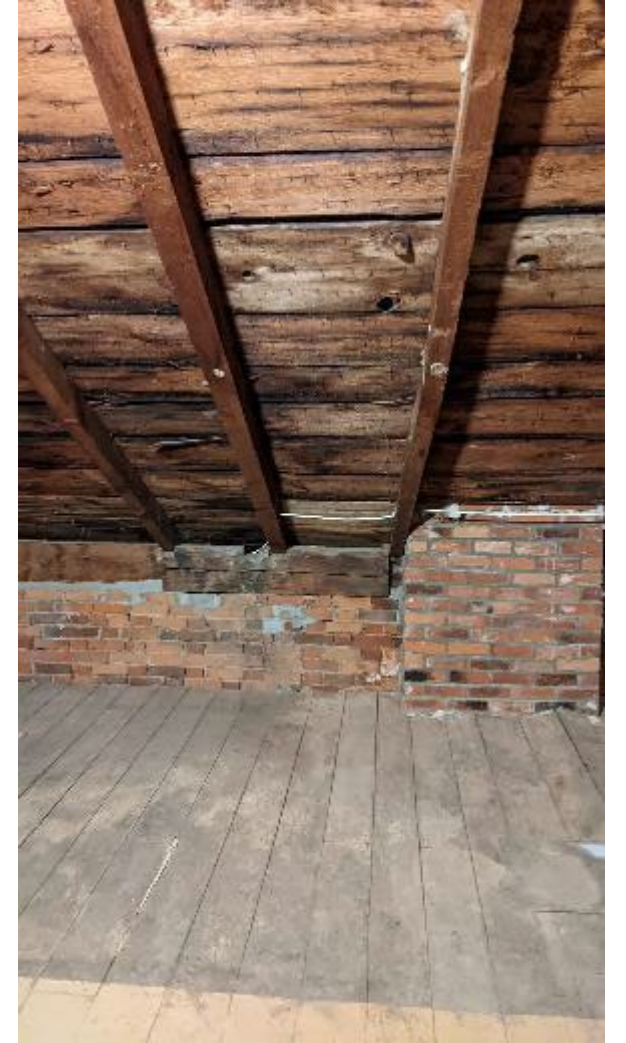
Rehabilitated Attic
