**Edwin Earl House
111 Mary Street
Milton, Ontario**

Heritage Impact Assessment

Prepared for Caroline and Andrew Kocher
by Robinson Heritage Consulting
16 August 2014

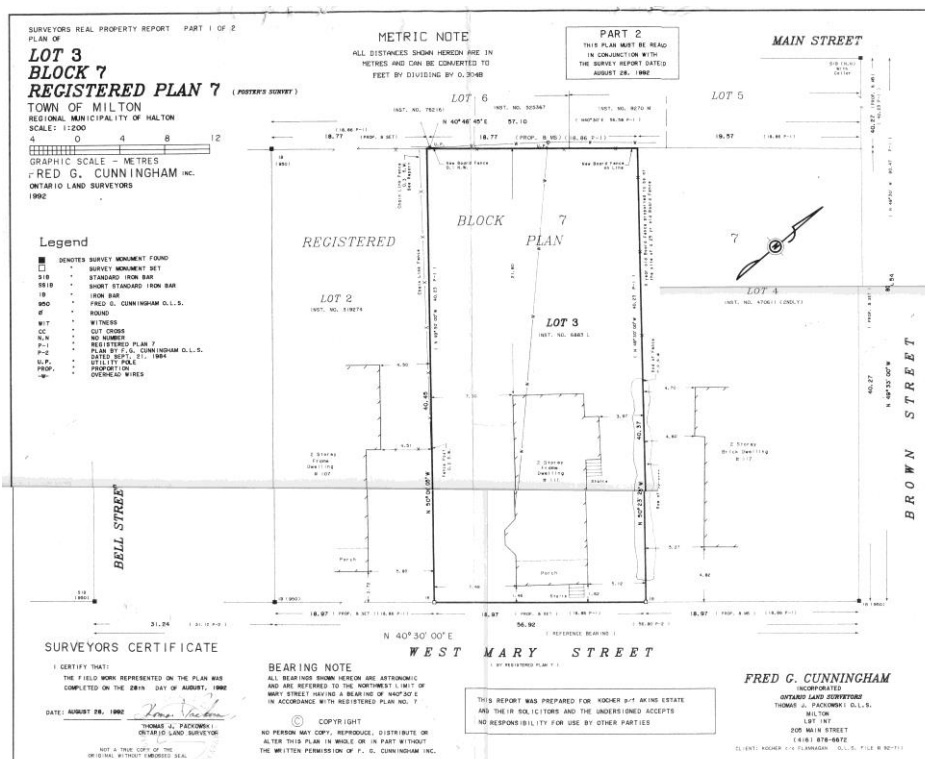
Figure 2 – Surveyor's Plan of Lot 3, Block 7, Plan 7 by Fred G. Cunningham, 1992 (Image source: property owner)

The subject property (Figures 1 and 2) is located at on the northwest side of Mary Street, between Brown and Bell Streets, facing Victoria Park. The subject property is described legally as being Lot 3 within Block 7 of Registered Plan 7 (Foster's Survey) in the Town of Milton.⁴ The subject property is a roughly rectangular property parcel measuring 18.97 m along Mary Street, 40.37 m along the northeast side lot line, 40.45 m along the southwest side lot line and 18.77 m along the rear lot line.⁵

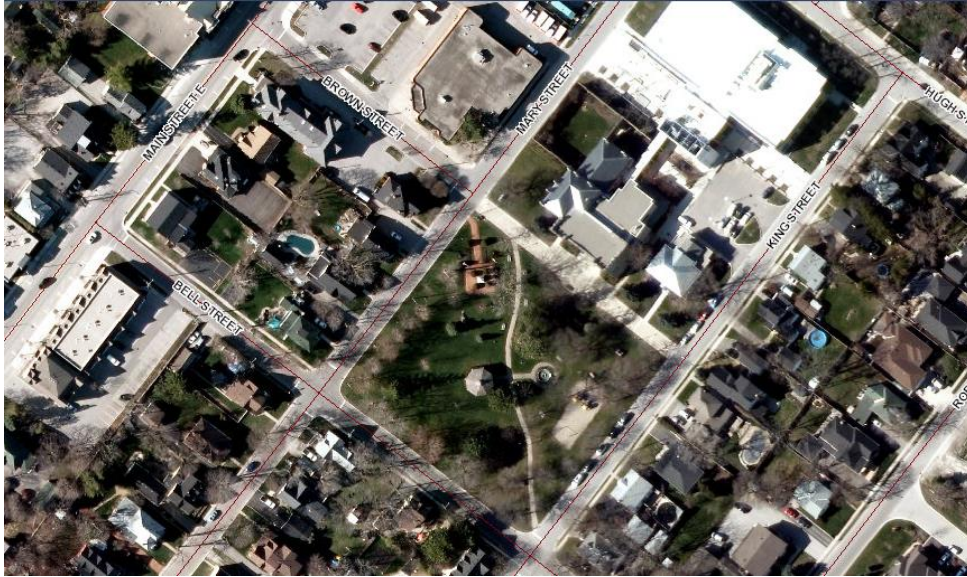
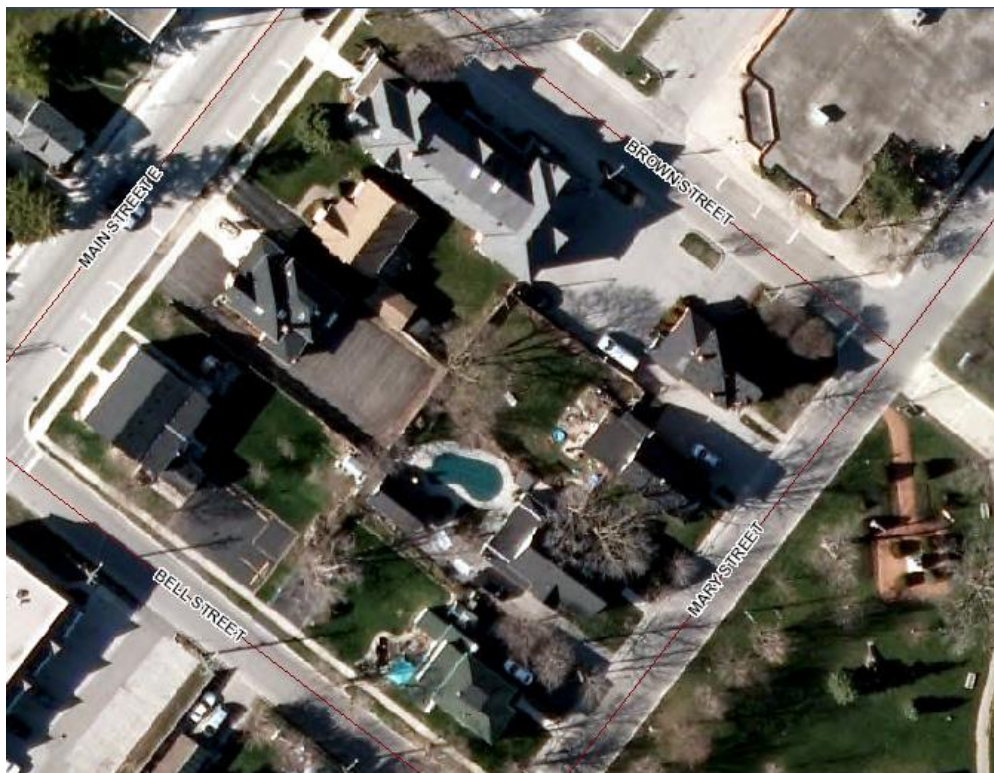
Figure 3 – 2103 Air photo. (Image source: Town of Milton GIS, accessed July 2014)

The subject property is within what is known in the Town of Milton Official Plan as “Old Milton” and is one of the original 19th century, Victorian homes built to front onto the northwest side of what was originally Court House Square (now Victoria Park) (Figure 1). The property is known legally as Lot 3 in Block 7 of Plan 7 (Foster’s Survey) and the parcel was surveyed in 1992 as shown in Figure 2. The present day context is seen in the 2013 air photo shown in Figures 3 and 4.

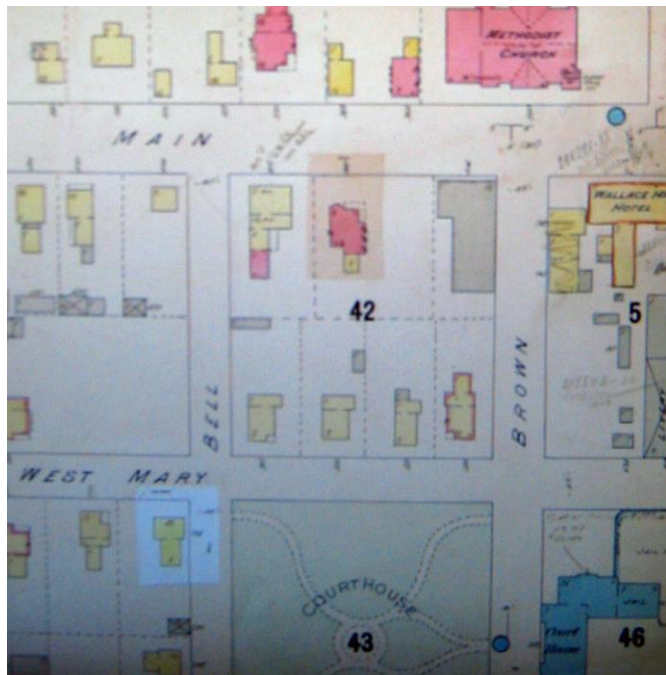
Figure 15 – Charles E. Goad, *Fire Insurance Plan for the Town of Milton*, May 1893 (Sheet 3).
(Image: Gore Mutual Archives, Cambridge).

Goad's 1893 Fire Insurance Plan for the Town of Milton (Figure 15) indicates Lots 1, 2, 3 and 4 in Block 7 of Plan 7 with dwellings facing Court House Square (now Victoria Square). Lot 3 shows a 2-storey, wood frame house with a wood shingle roof and a footprint similar to the existing house at 111 Mary Street. It should be noted that porches are indicated on the dwellings at what are now 117 Mary Street, 99 Mary Street and 100 Main Street East. No front porch (open or enclosed) is indicated on 111 Mary Street but the front façade is indicated as protruding well past that of 117 or 107 Mary Street. Therefore, it is possible that the enclosed upper storey of the front porch is shown as an extension of the main floor footprint without indicating the open main floor porch beneath, similar to the house today indicated on the surveyor's plan in Figure 2. No bay window is indicated on the southwest wall of 111 Mary or on the front of 107 Mary Street.

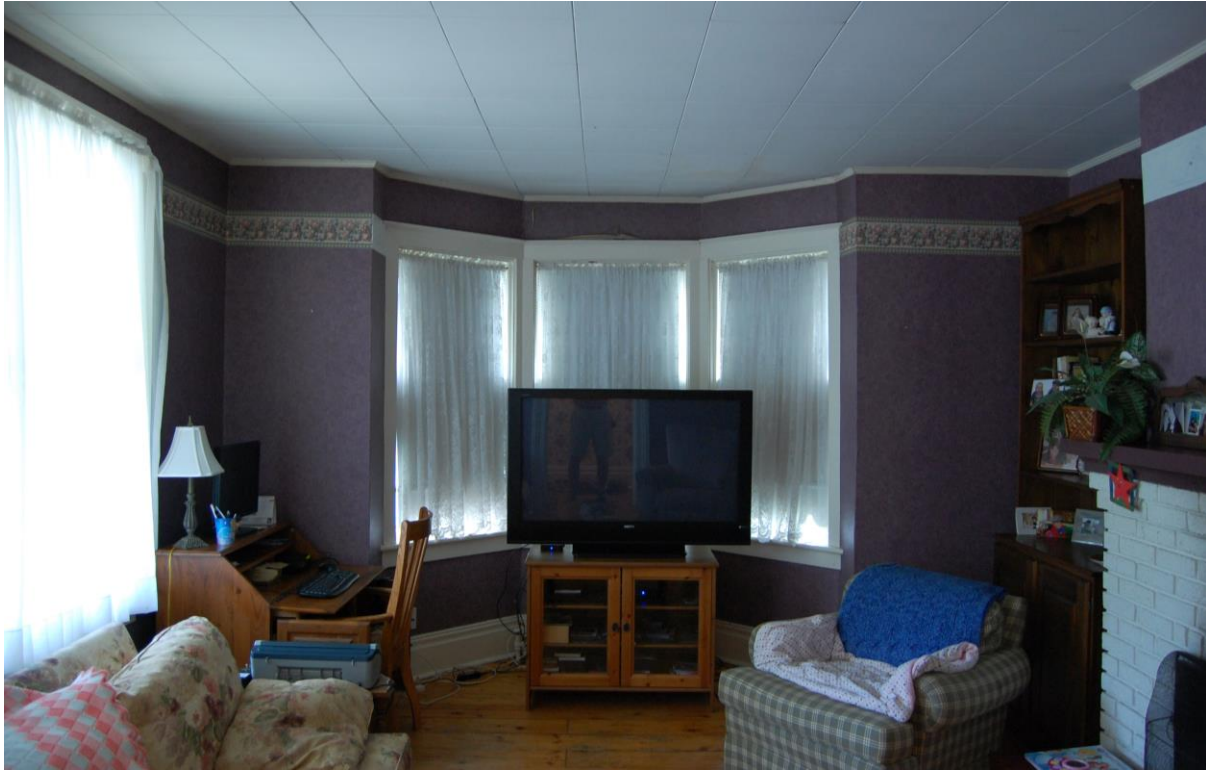
Figure 54 (Photo: RHC, June 2014)

Figure 54 shows the view from the front hall to the front room. The front room has a dropped ceiling with modern acoustic tile, medium width plank floors, a bay window and a central fireplace. The front two windows display what is likely the original window casing, stool and skirt profiles - the latter with ends cut at a slight angle and with a simple bead along the bottom edge (Figure 57). The sashes are constructed with doweled, flat butt joint corners (Figure 58). The sash lock in the front right window has patent date of “1874” (Figure 58).

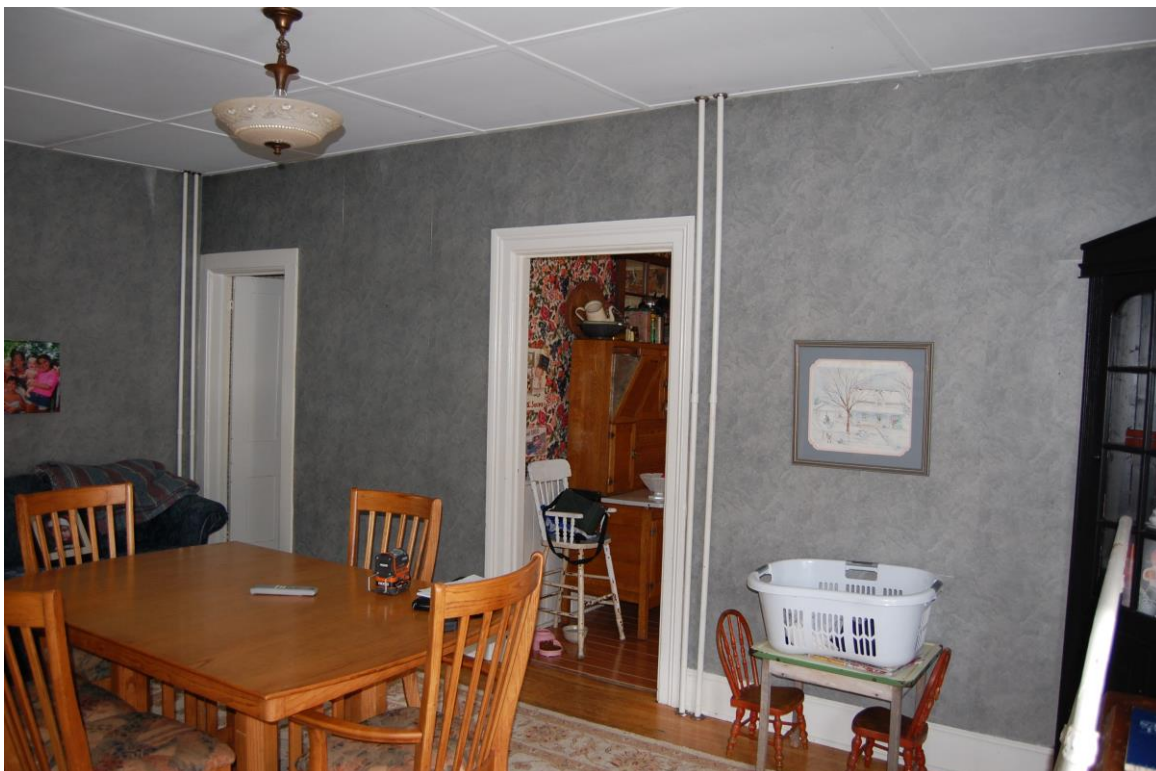
Figure 71 (Photo: RHC, June 2014)

This central wall is also shared by the dining room area which has a door to a back corner bedroom and a door to the kitchen (Figure 71). The dining room and kitchen floors have been covered with hardwood strip flooring and the dining room has an older type of dropped ceiling with larger panels than the modern acoustic tiles of the front room. The kitchen has what may be the original wood tongue-and-groove ceiling (Figure 77) and wood wainscoting (Figure 78). Figures 83 to 87 show an impressive built-in, Victorian kitchen cupboard with diagonal, tongue-and-groove inset panels and butterfly hinges – quite likely a feature of the original house.

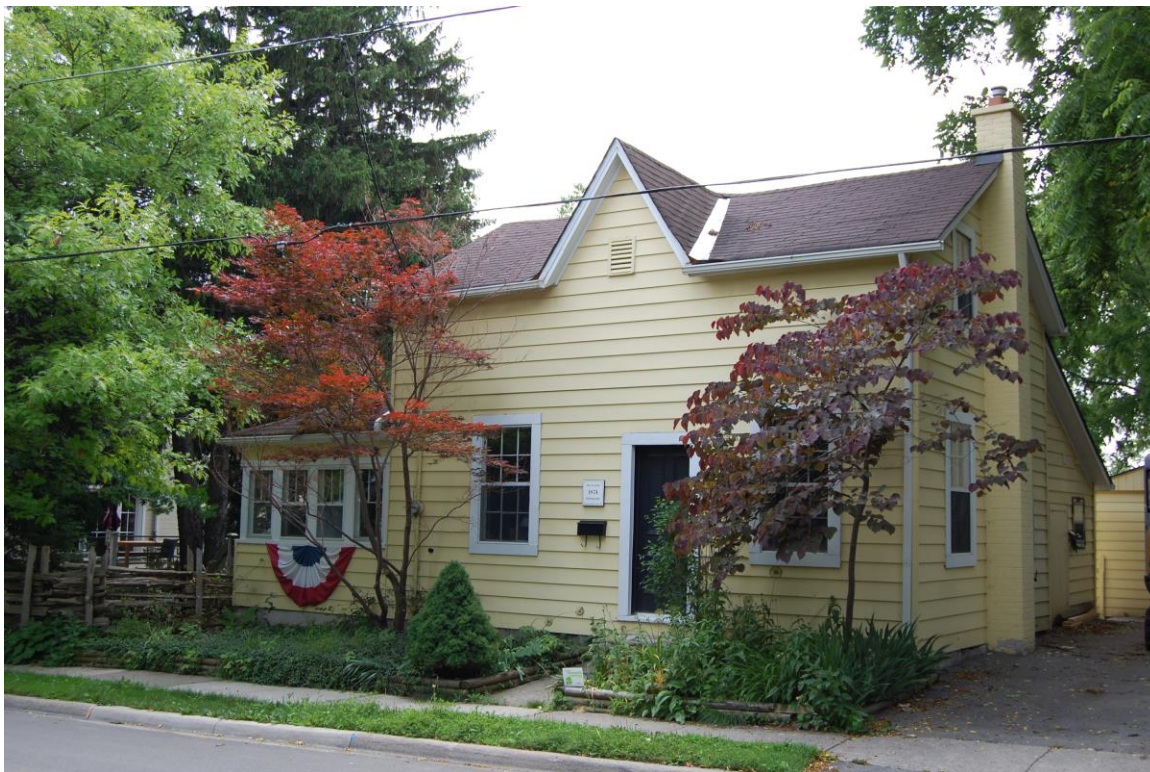
Figure 149 – 48 Bell Street (Photo: RHC, June 2014)

(Figure 150)³ and 48 Bell Street - an asymmetrical 3-bay, Ontario cottage style house, indicated as being built about 1874 and occupied by Thomas Lavery, stonemason (Figure 149).
