Appendix 3

Photographic Record \_ Heritage Attributes \_ 10266 2nd Line, Campbellville

# Physical Heritage Attributes

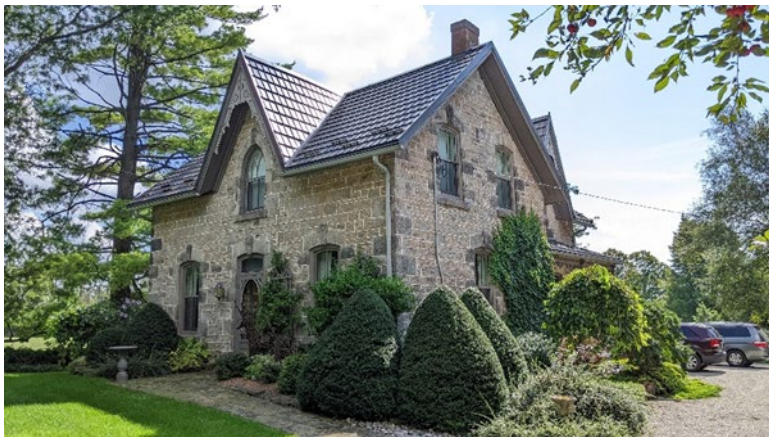
North Elevation

One and a half Gothic Revival Stone home with medium cross gable, two dormers and two brick chimneys

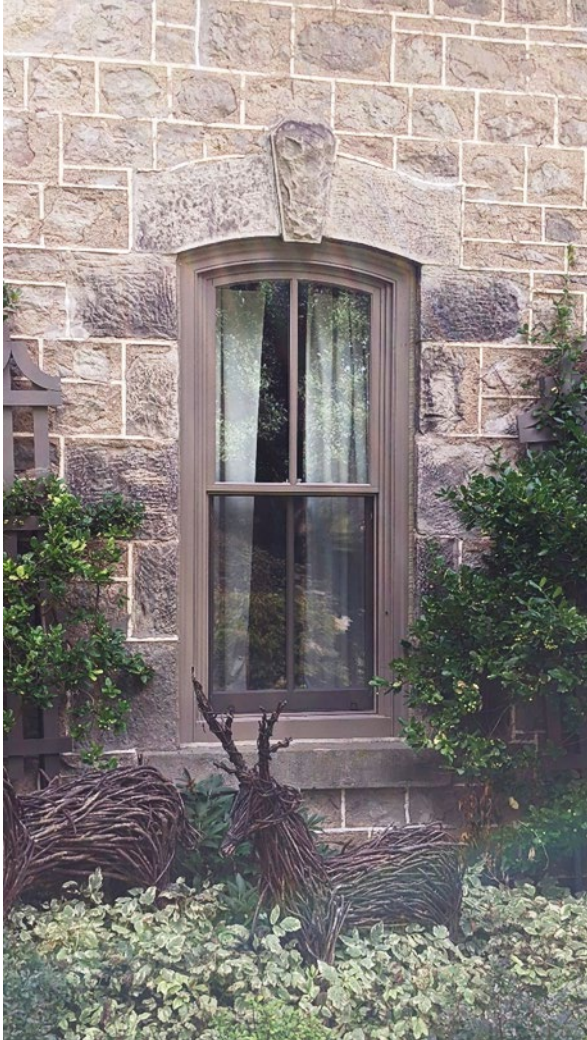
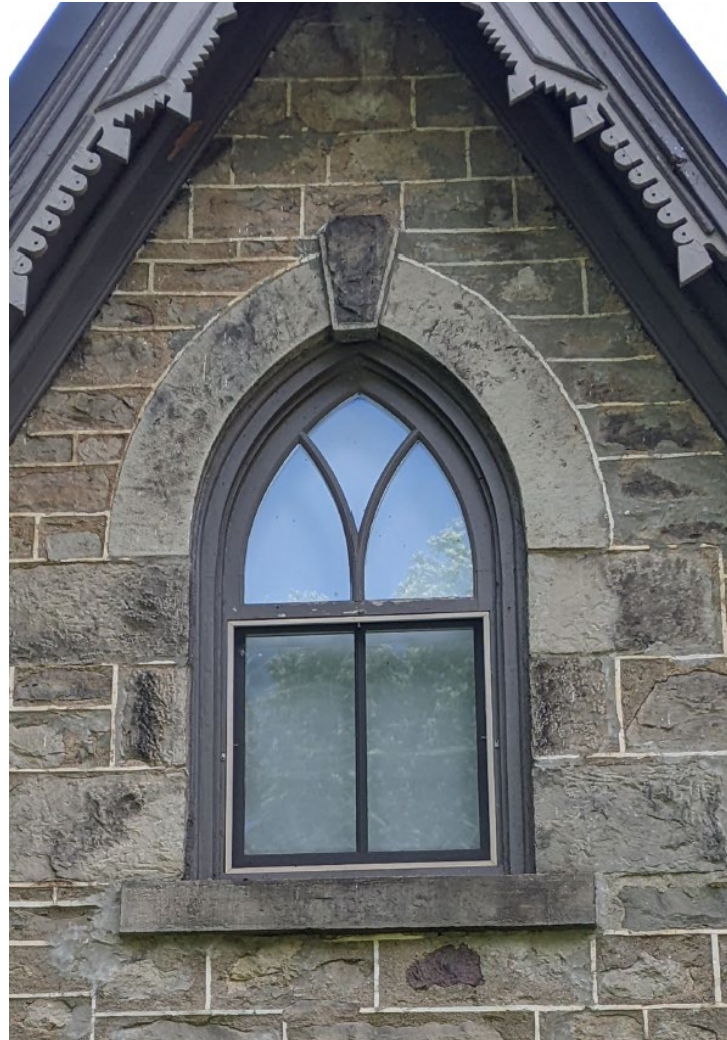
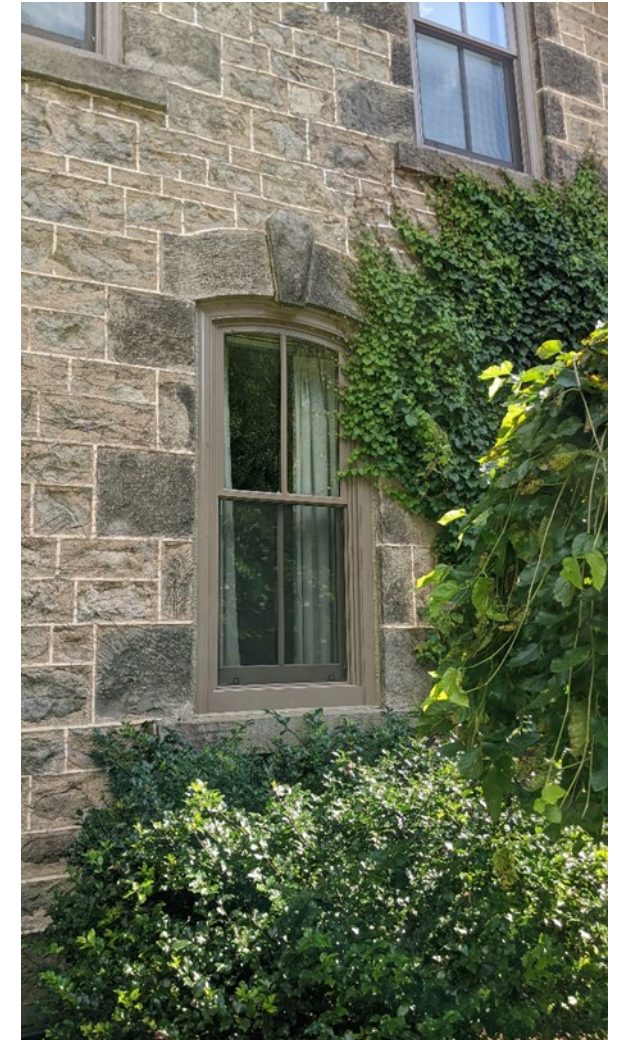
- Two Sash, two-over-two segmented arch windows with plain mouldings, heavy stone arch lintel with keystone and plain lug stone sills
- Gothic pointed arch lancet windows at centre gable ends at North and West window with stone lug sill and pointed arch lintels with keystone.

Ground Floor Window North elevation

Central Gable Window North Elevation

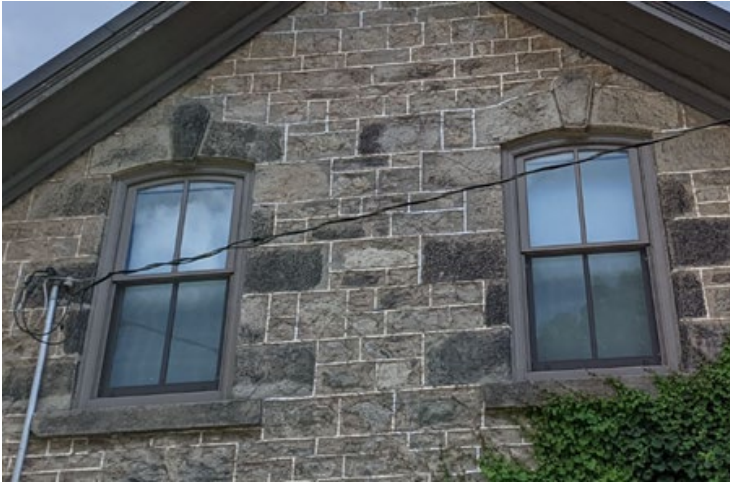
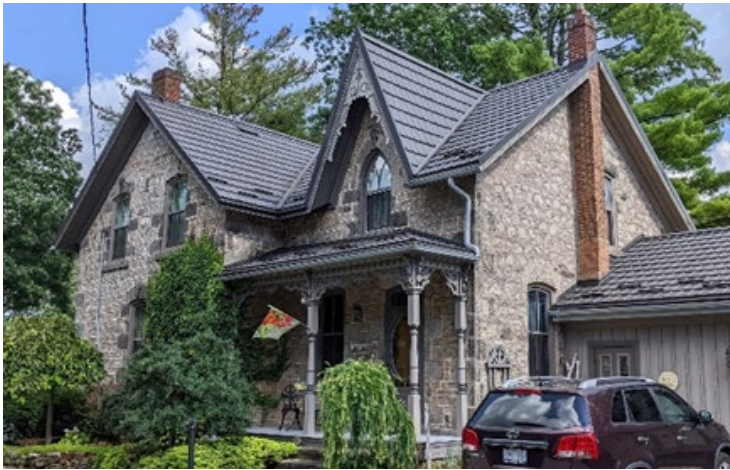
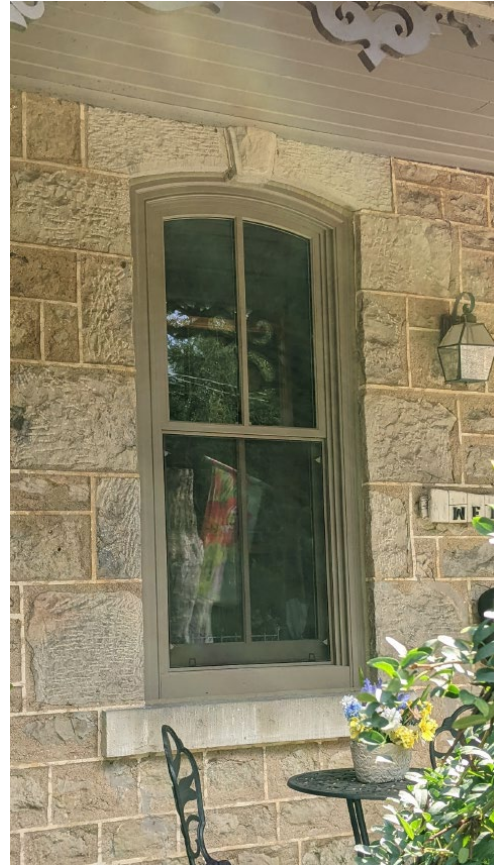
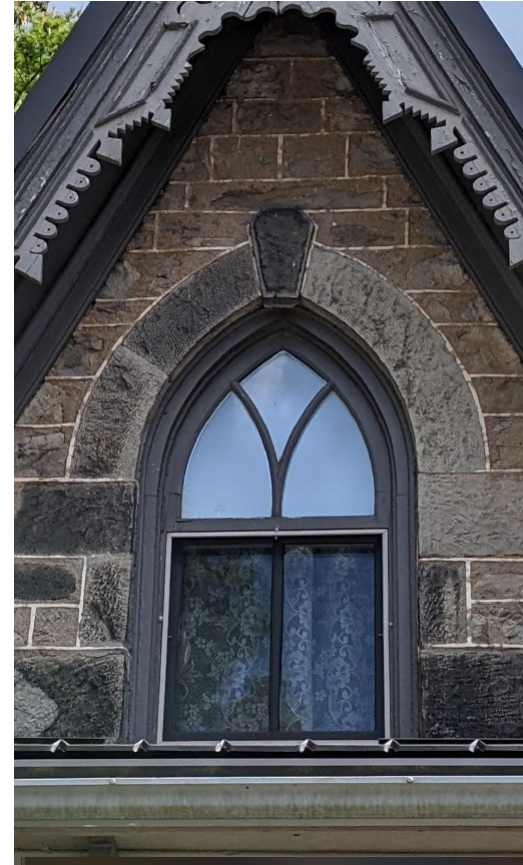
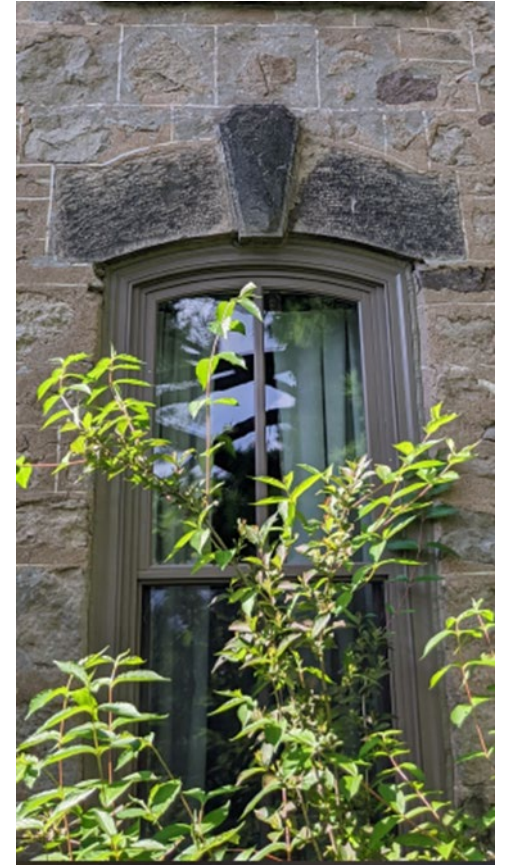
- Two Sash, two-over-two segmented arch windows with plain mouldings, heavy stone arch lintel with keystone and plain lug stone sills
- Gothic pointed arch lancet windows at centre gable ends at North and West window with stone lug sill and pointed arch heavy stone lintels with keystone.

Windows West Elevation Upper Floor

Window West Elevation  
Porch

Window West Elevation  
Central Gable

Windows West Elevation  
Ground Floor

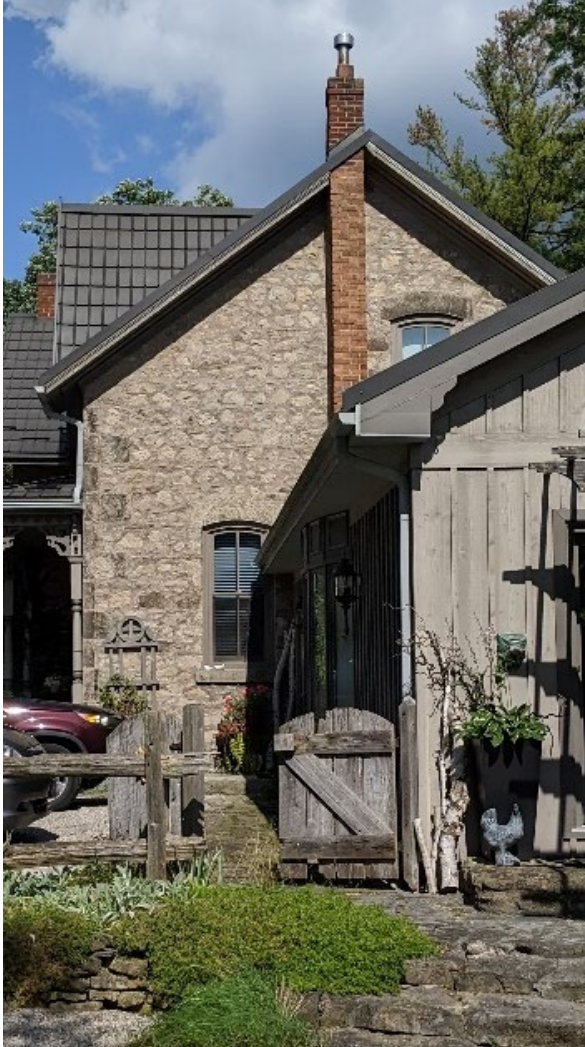
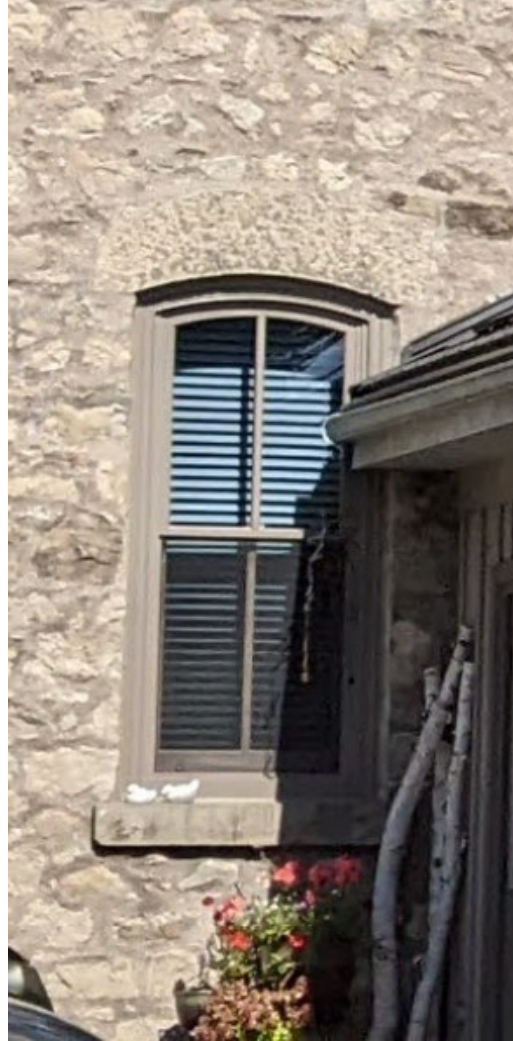
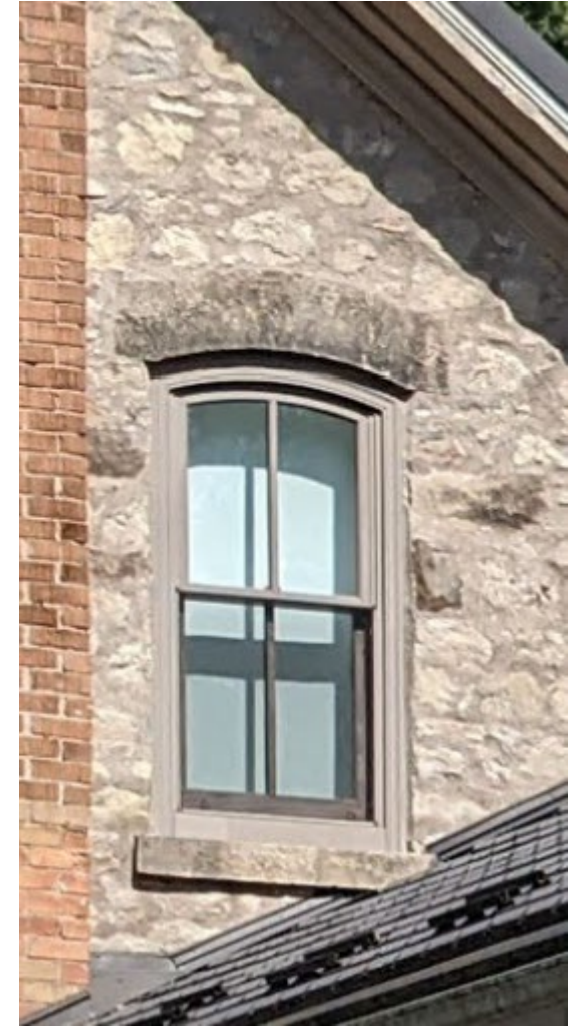
Two Sash, two-over-two segmented arch windows with plain mouldings, heavy stone arch lintel with keystone and plain lug stone sills

South Elevation Ground Floor Windows

South Elevation upper Floor Window

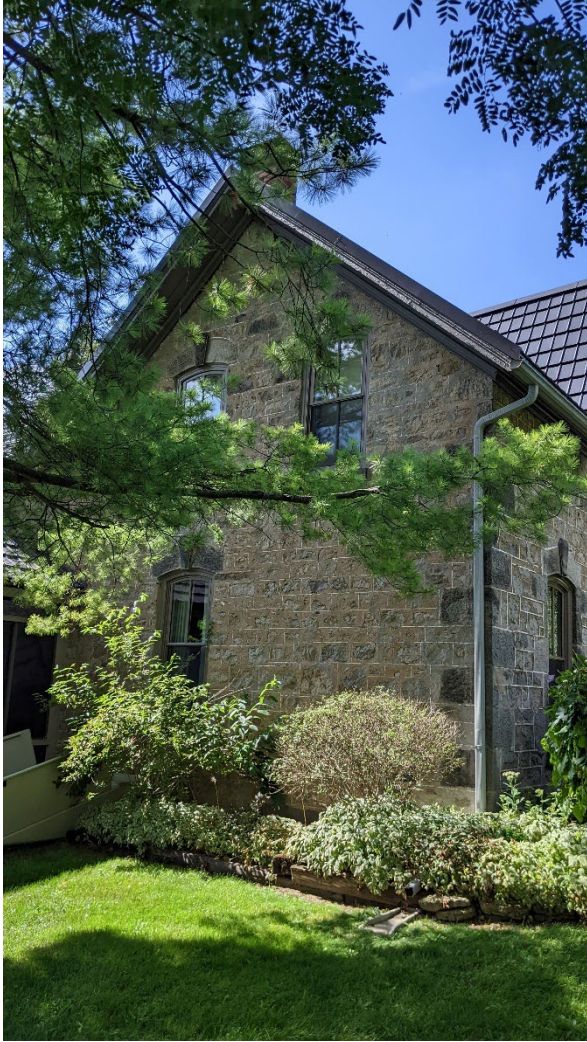
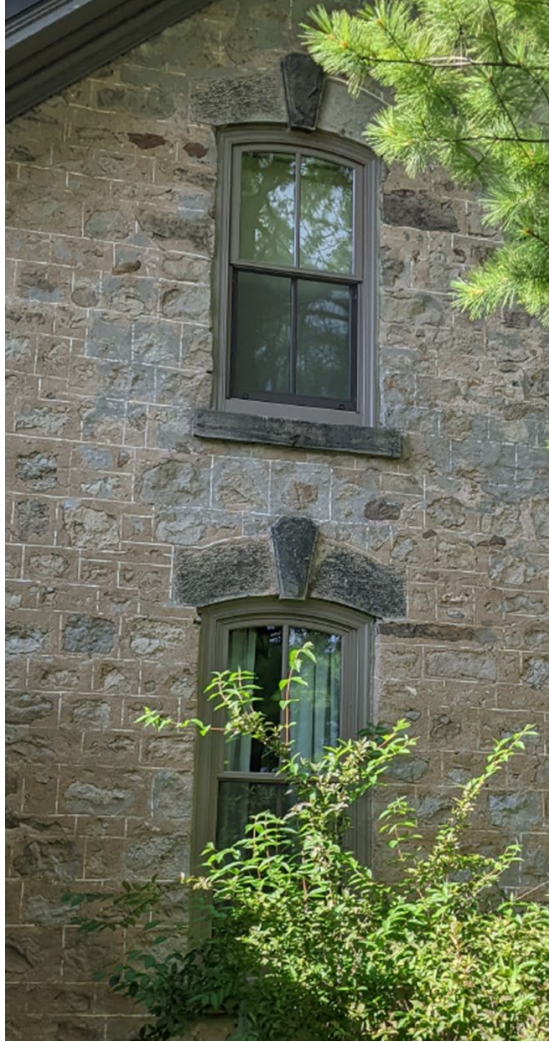
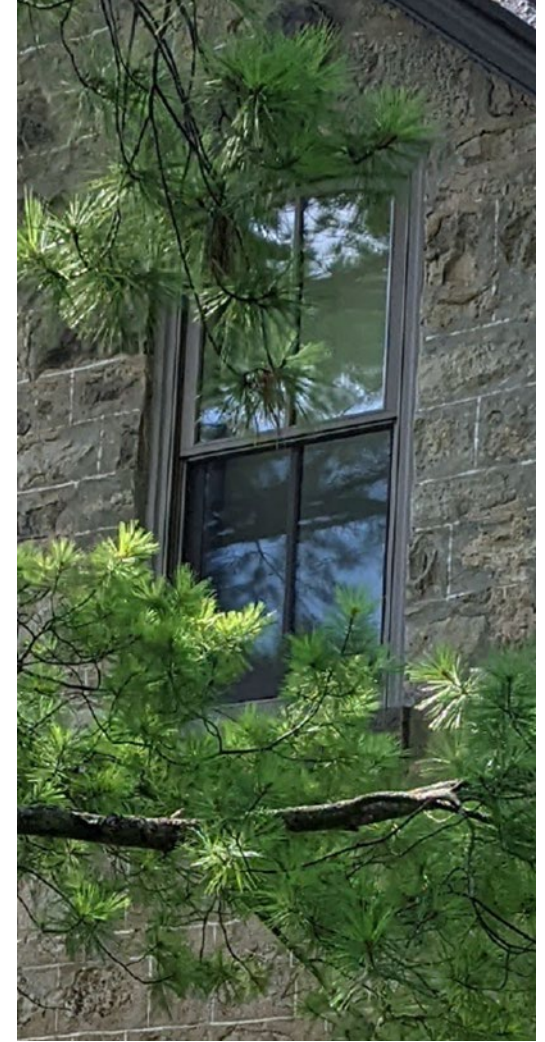
Two Sash, two-over-two segmented arch windows with plain mouldings, heavy stone arch lintel with keystone and plain lug stone sills

East Elevation Windows

East Elevation Windows upper Floor Window

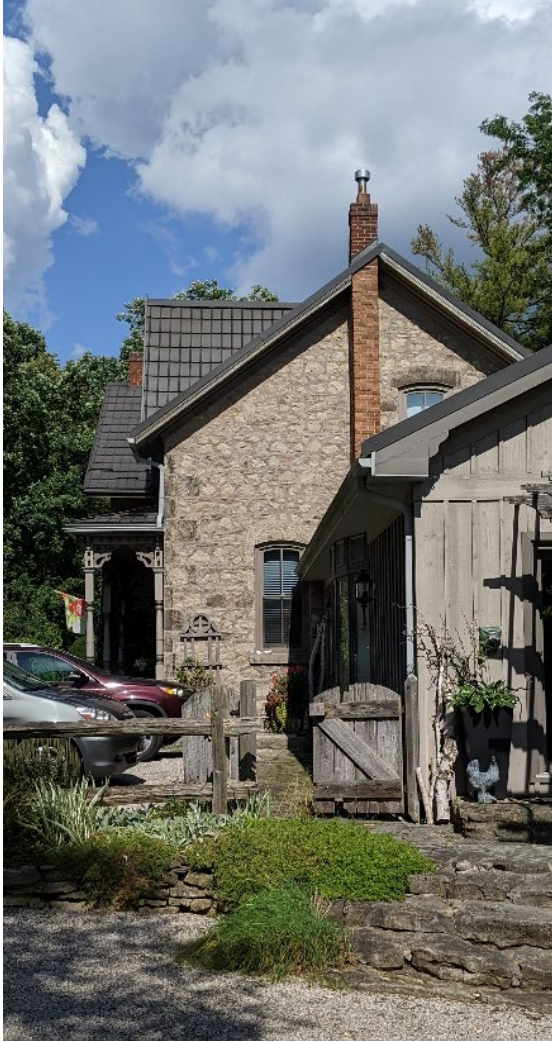
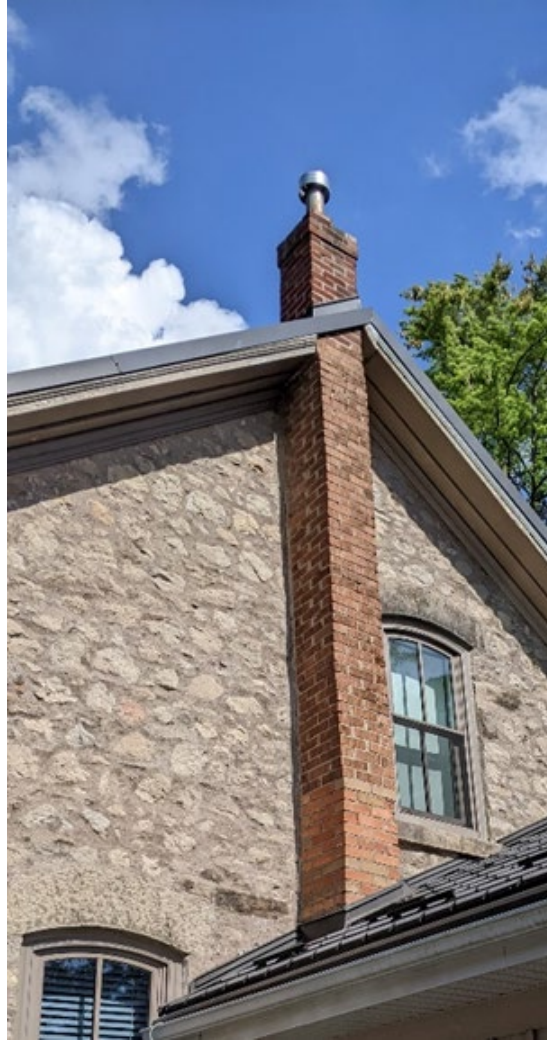
A left side brick chimney at the West elevation and an exterior rear brick chimney on the South elevation

Chimney South Elevation

Chimney West Elevation

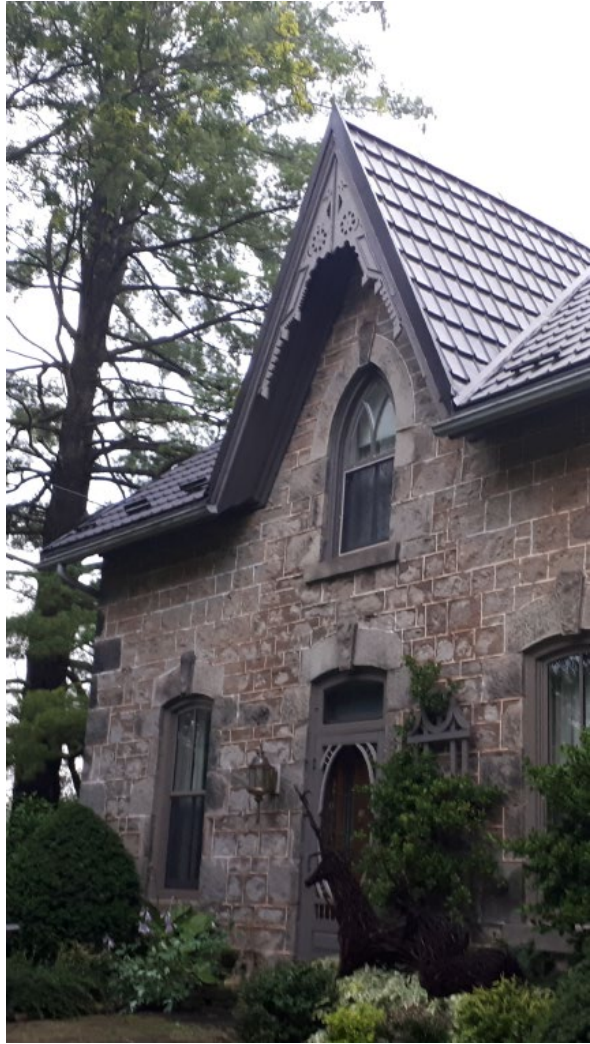
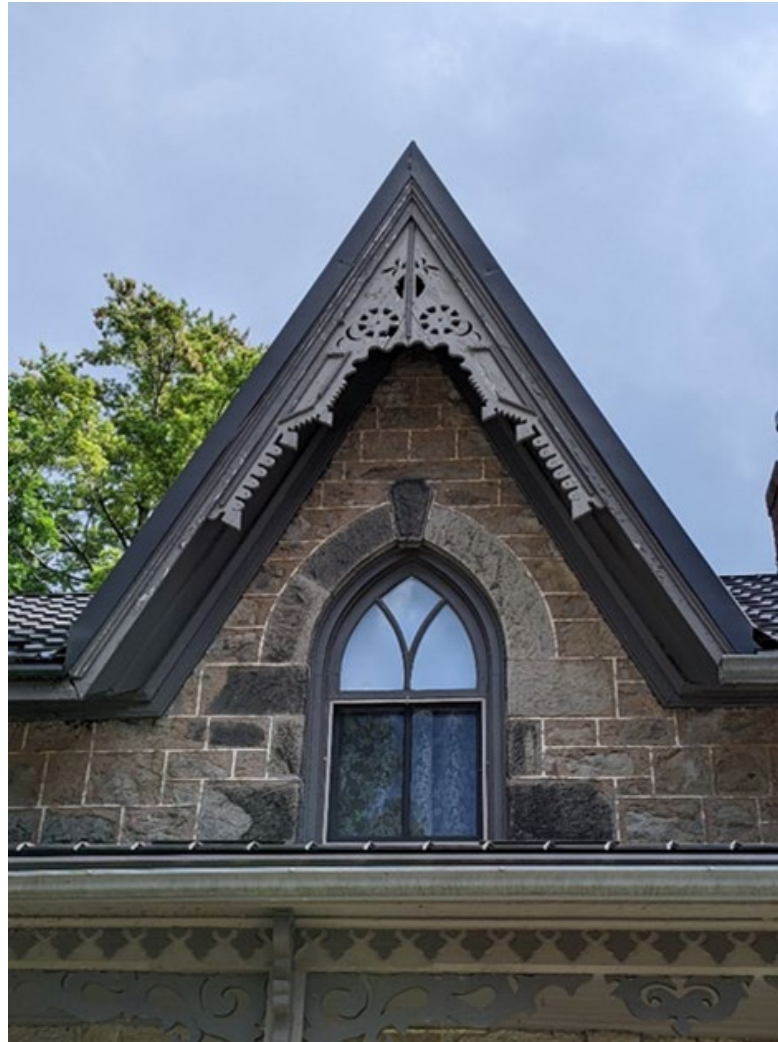
Decorative verges or ginger bread on the central gable of the North and West elevations

Decorative Verges on the North Elevation

Verges Details

Decorative Verges on the West Elevation

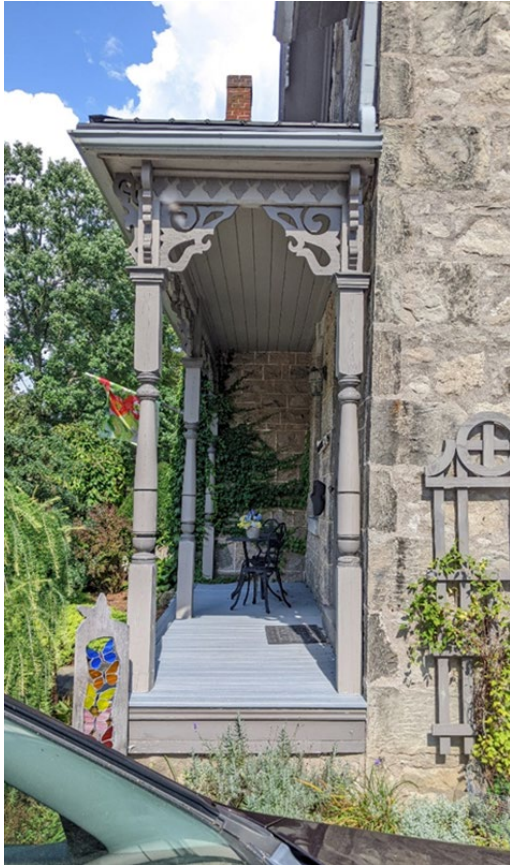
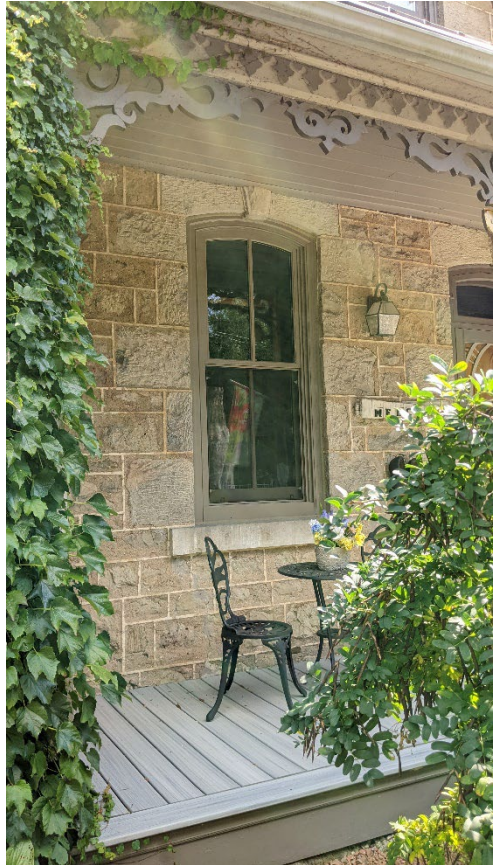
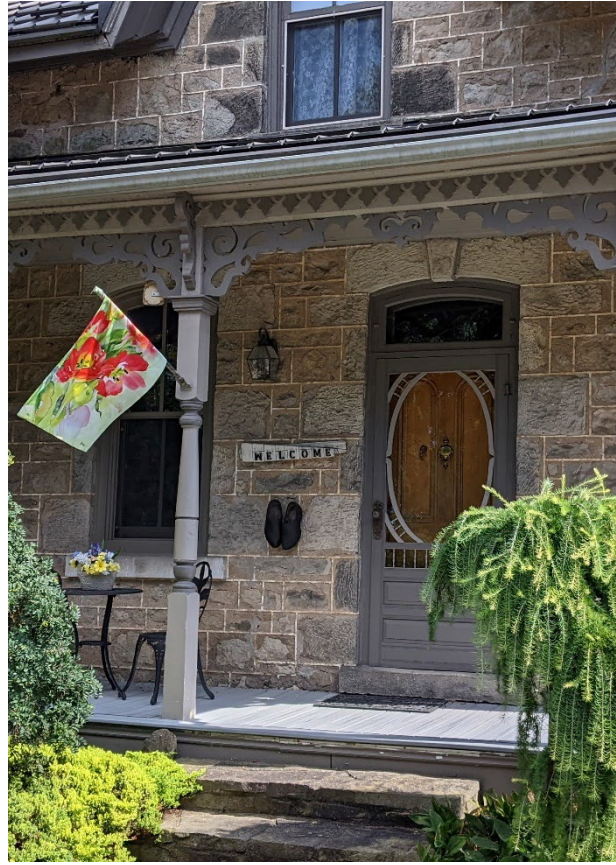
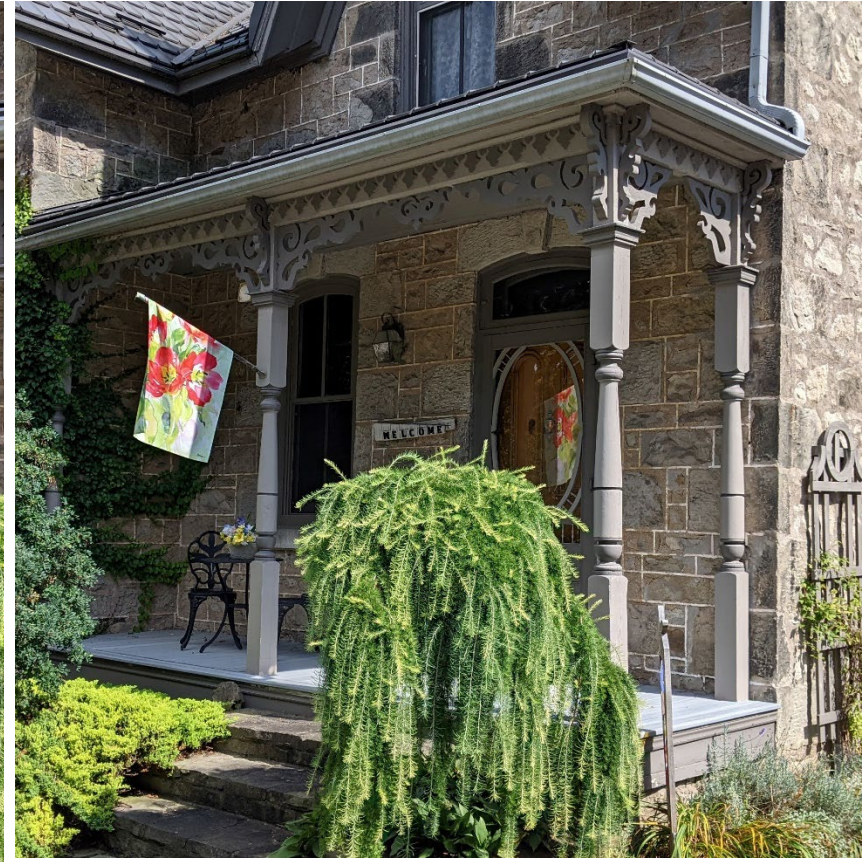
Open ornate side porch with straight steps, decorated timber post and fretworks

Decorative post and fretworks

Decorative fretworks and window

Side Entrance Porch Door

Side Entrance Porch West Elevation

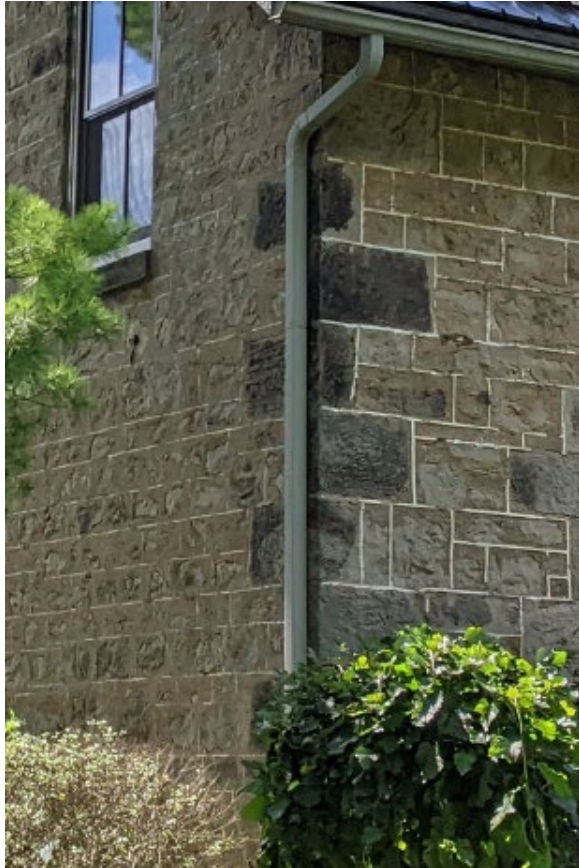
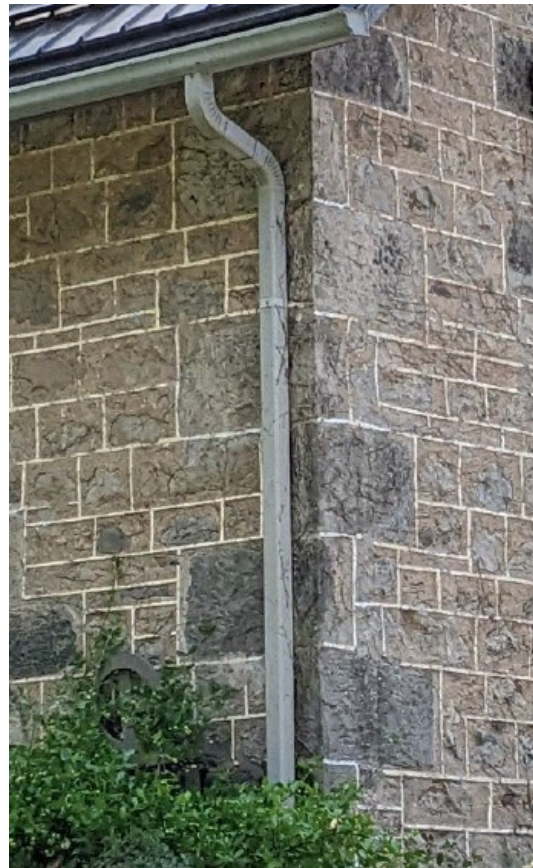
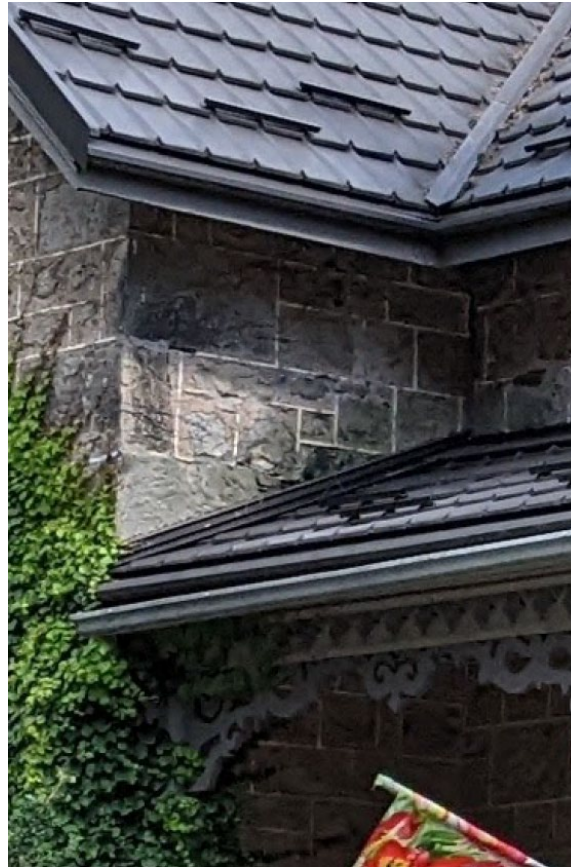
- Broken course cut stone on exterior of building with quins at corners at North, East and West elevation
- Random course field stone at South elevation

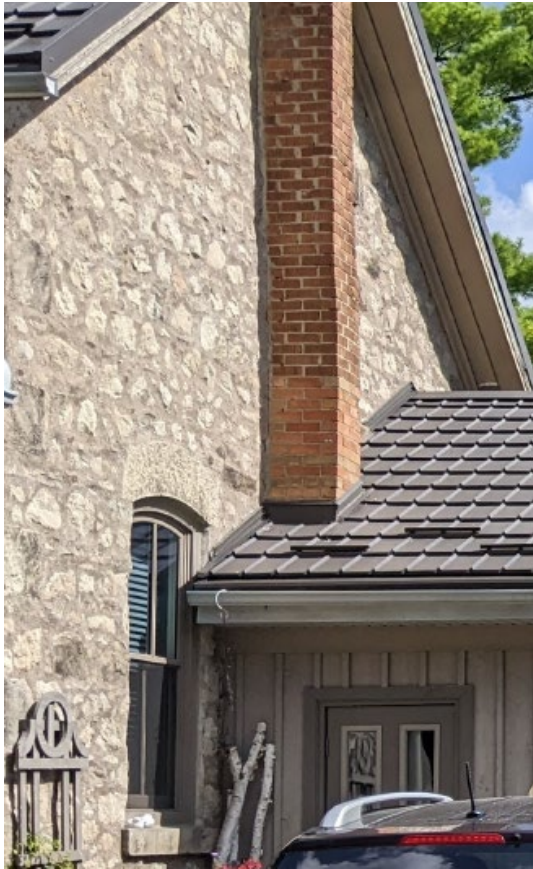
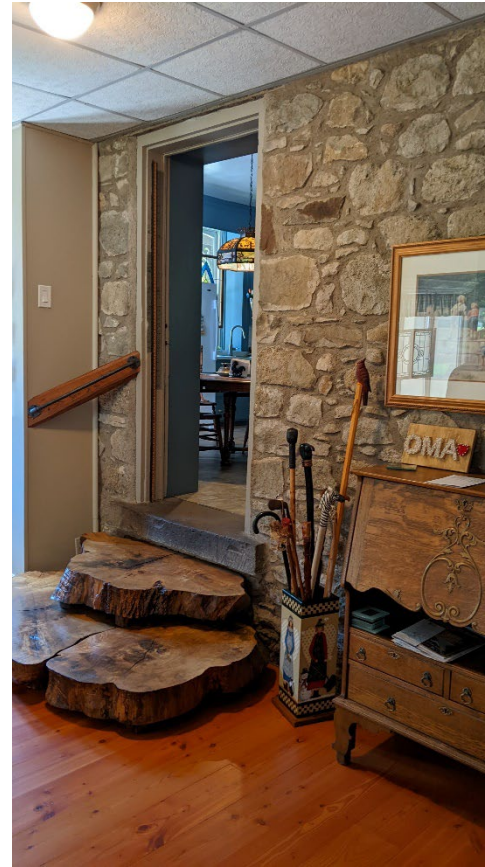
Random Course field stone at interior interface of historical home and new additions

Interface Historic house and addition

Interior Interface Historic house and addition

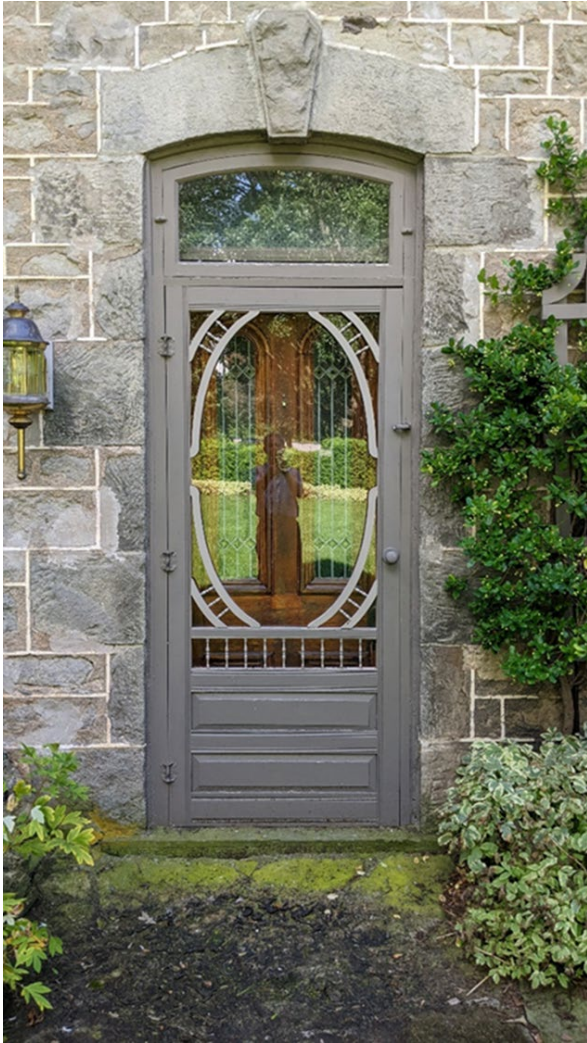
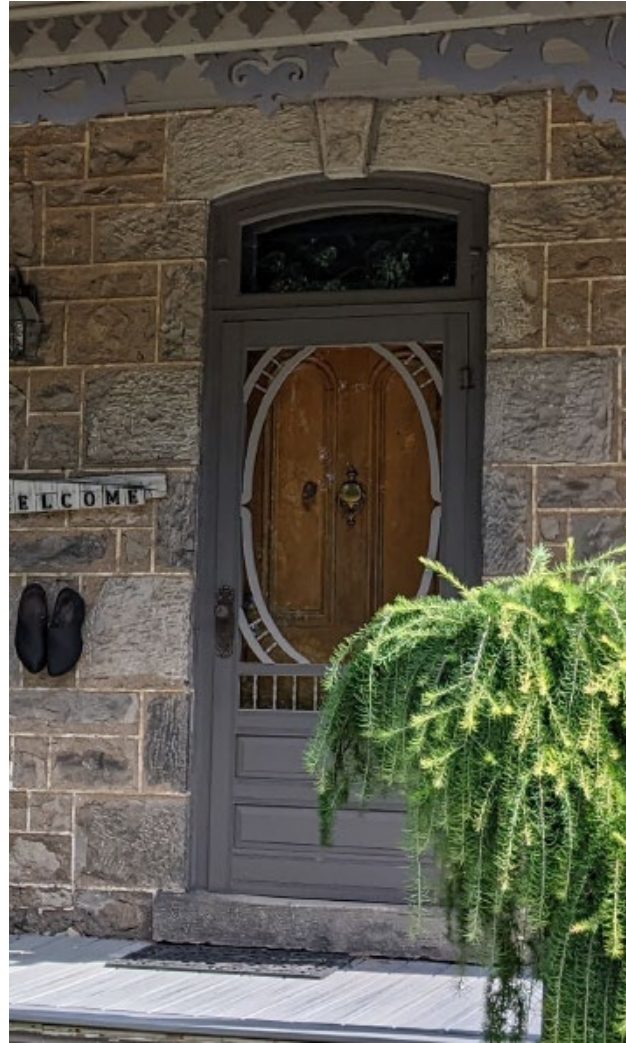
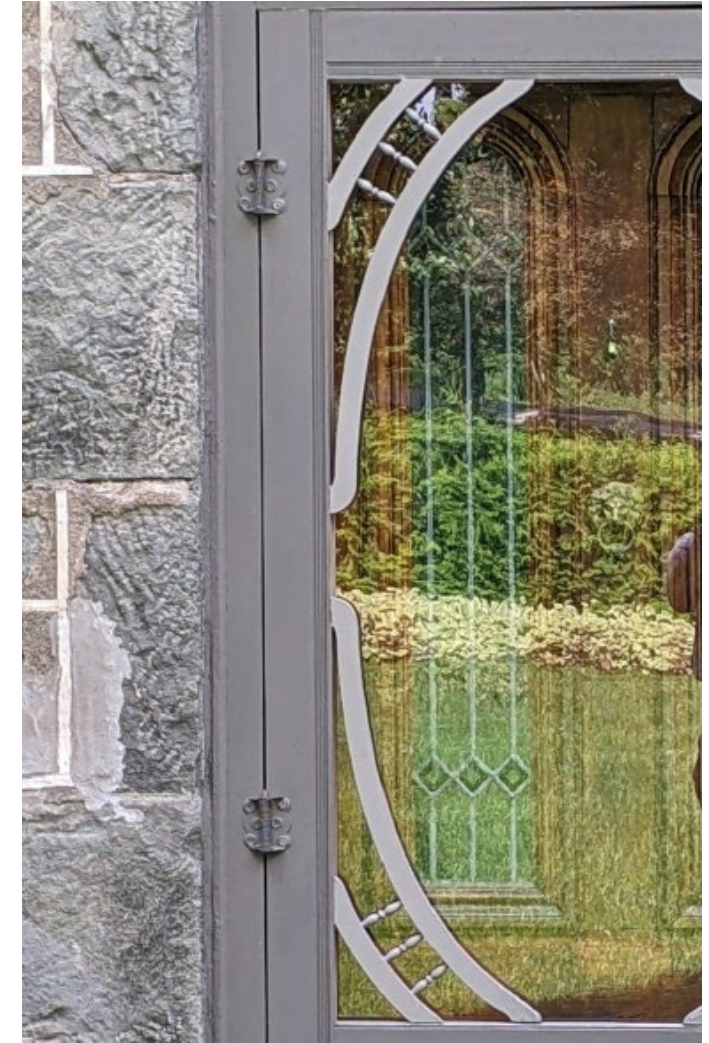
- Single leaf three-panel wood entrance door with stain glass insert on the middle panel, clear segmented arch transom and heavy stone lintel at North Elevation
- Single leaf three-panel wood entrance door clear segmented arch transom and heavy stone lintel at West Elevation

Door on North Elevation

Door on West Elevation

Stain Glass Insert Detail

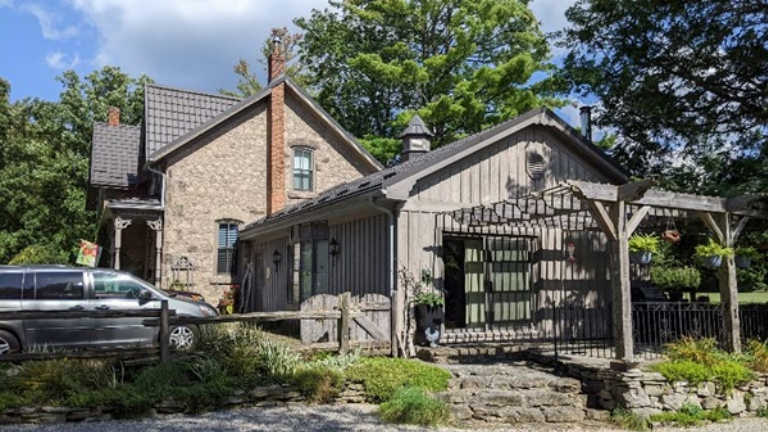
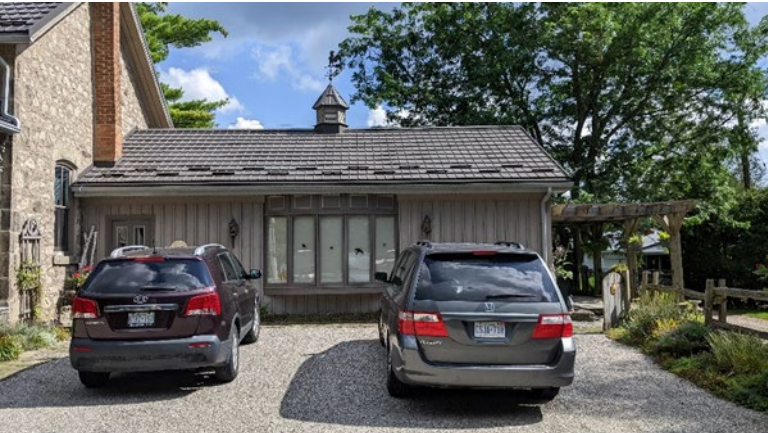
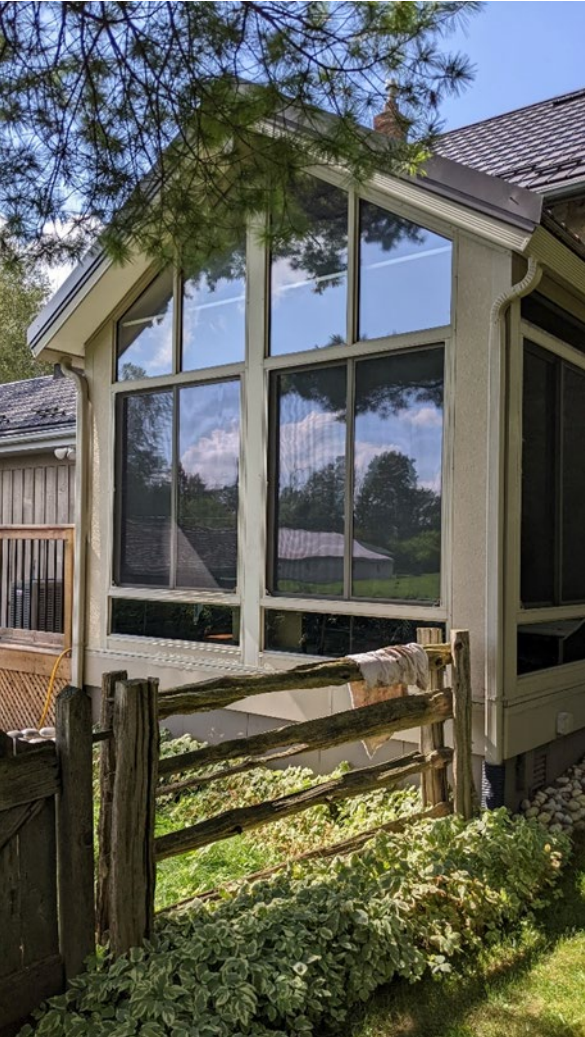
Additions to the south of the property

Rear Extension

Rear Extension (side elevation)

Rear Sunroom Addition

Rear Brick Chimney?
