Table 1: Heritage Attributes of the Hogg House (22 King Street), Milton, Ontario

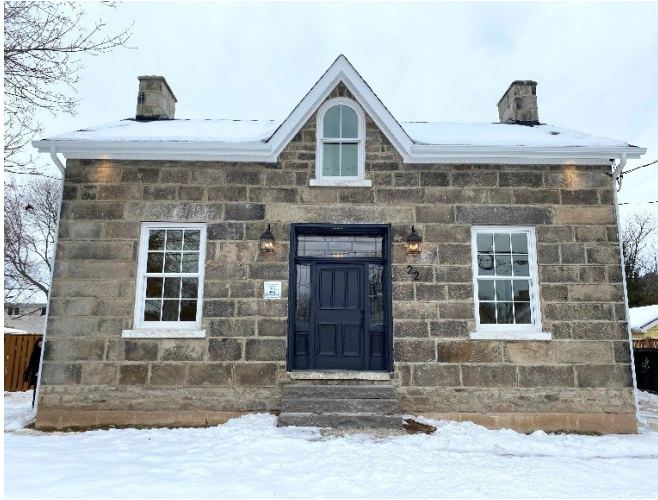
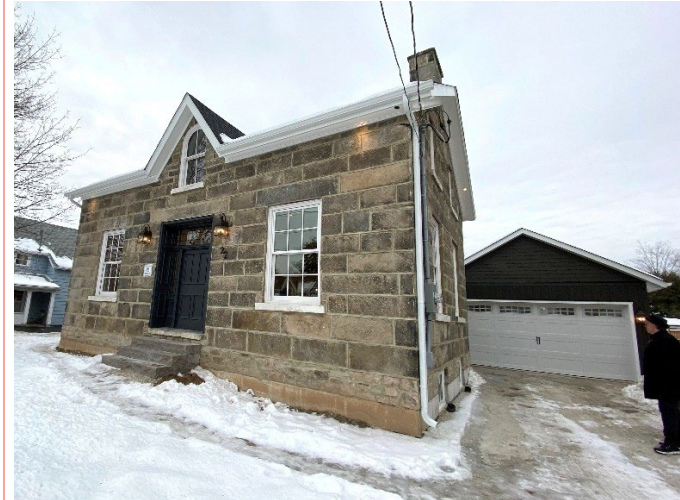
Gothic Revival style composition with three-bay, storey-and-a-half massing.

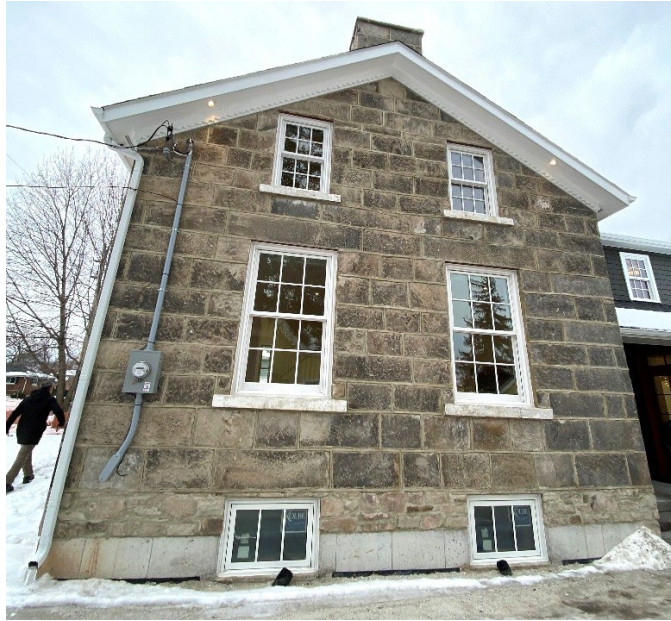
Medium side gable roof with central cross-gable

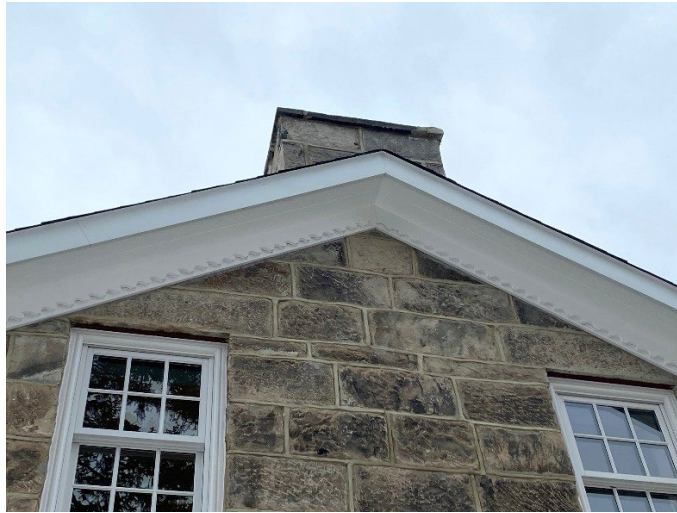
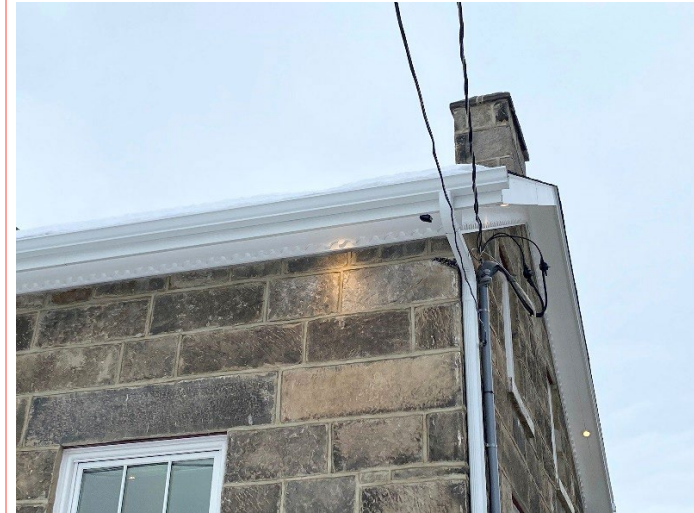
Stone chimneys with chamfered caps inside both end walls

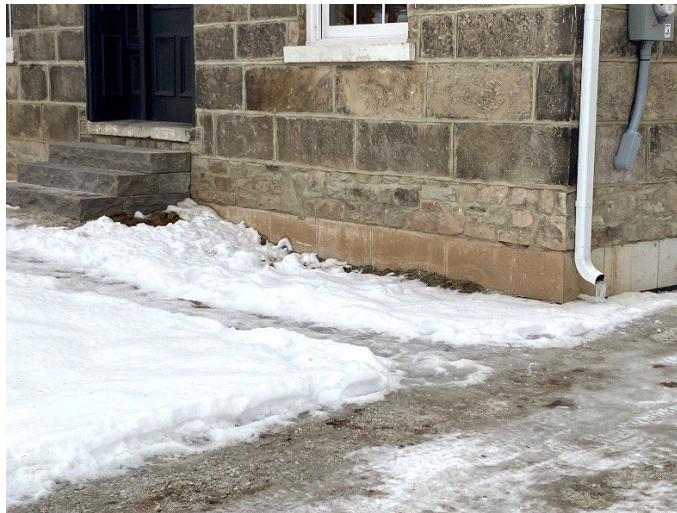
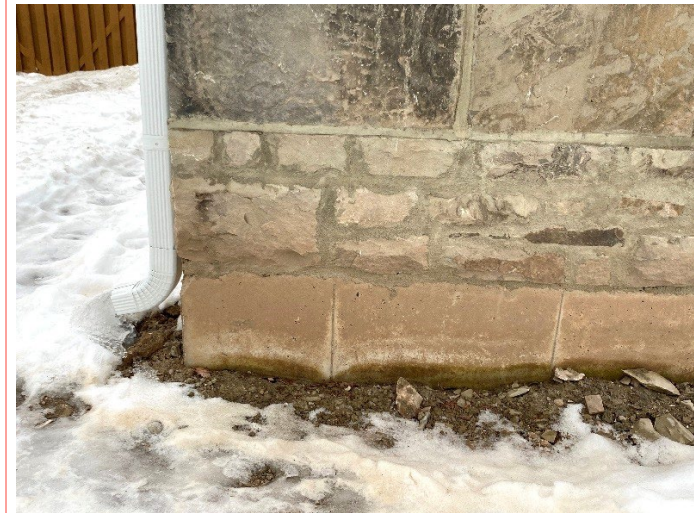
Load-bearing walls built in chiselled ashlar masonry laid in regular courses

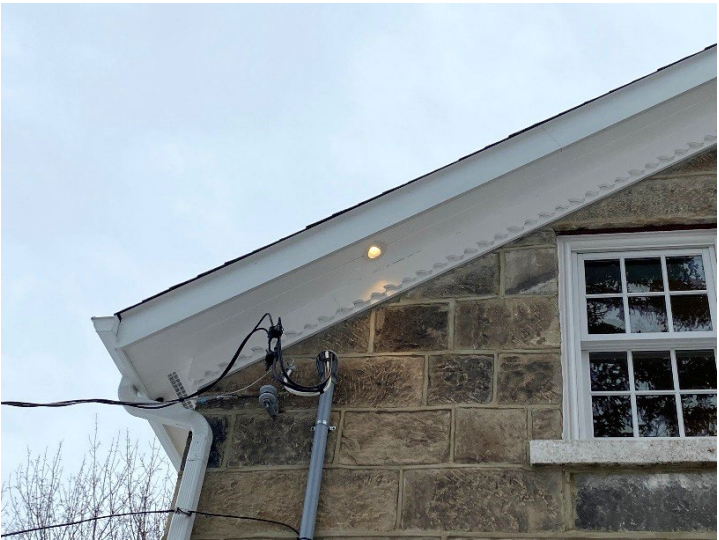
| Heritage Attribute | Photograph |
|---|---|
| <p>Wood frieze with nebuly or nebulé moulding</p> | <p>A photograph showing a close-up of a stone wall under a white roofline. A decorative wood frieze with a nebuly or nebulé pattern is visible along the eaves. A window with a white frame is partially visible to the right.</p> |

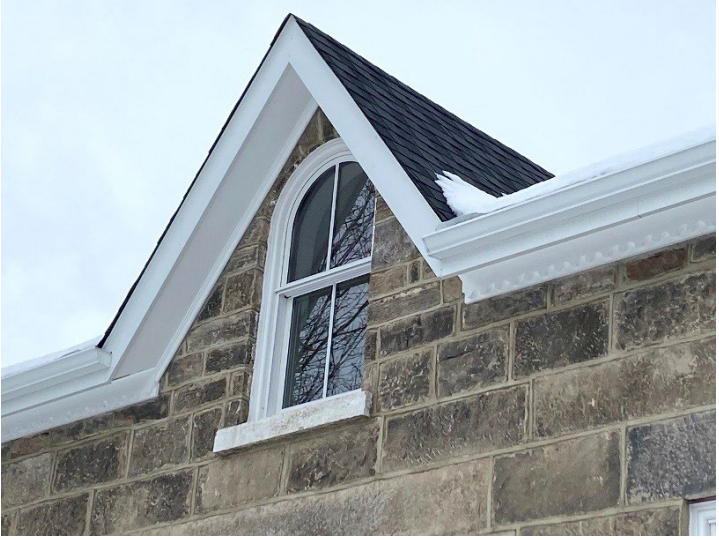
| Heritage Attribute | Photograph |
|---|---|
| <p>Window opening in the cross-gable with semi-circular arch head formed with small stone voussoirs</p> | <p>A photograph of a window set within a cross-gable roof structure. The window has a semi-circular arch head, which is constructed from small, light-colored stone voussoirs. The wall is made of larger, rough-hewn stone blocks.</p> |

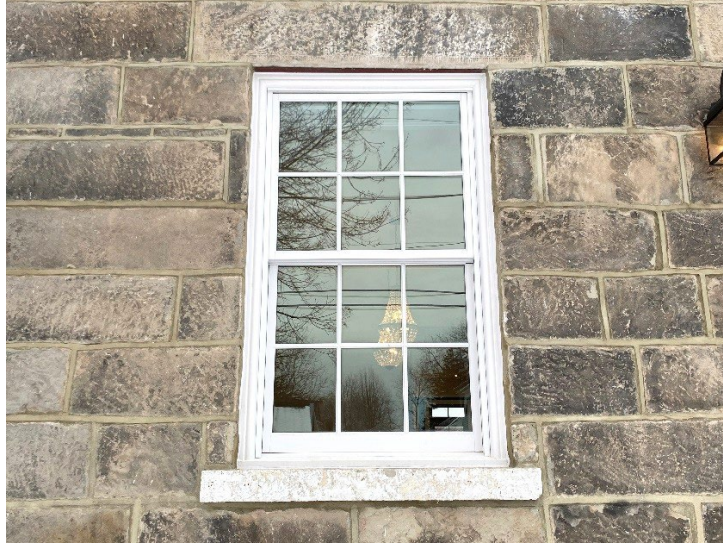
Symmetrical fenestration on the front façade and end walls defined by plain stone lug sills and heavy stone lintels that are bush hammered with chiselled margins

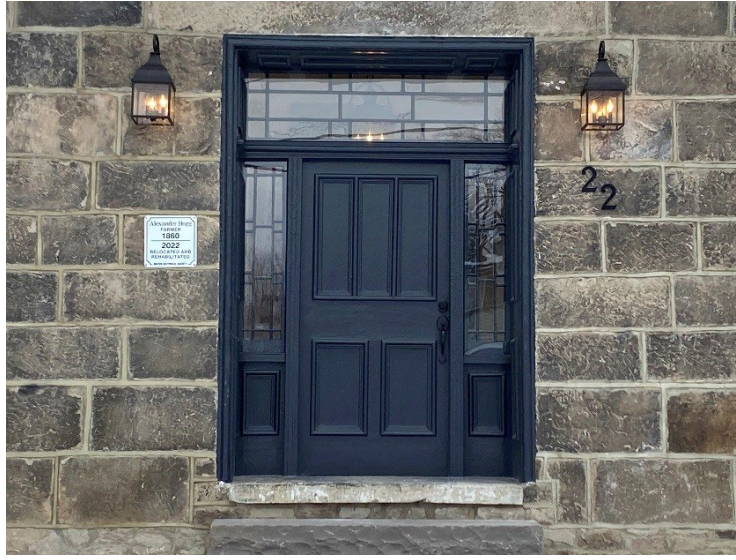
Wide central entrance with interior and exterior multi-pane transoms and sidelights and wood five-panel door

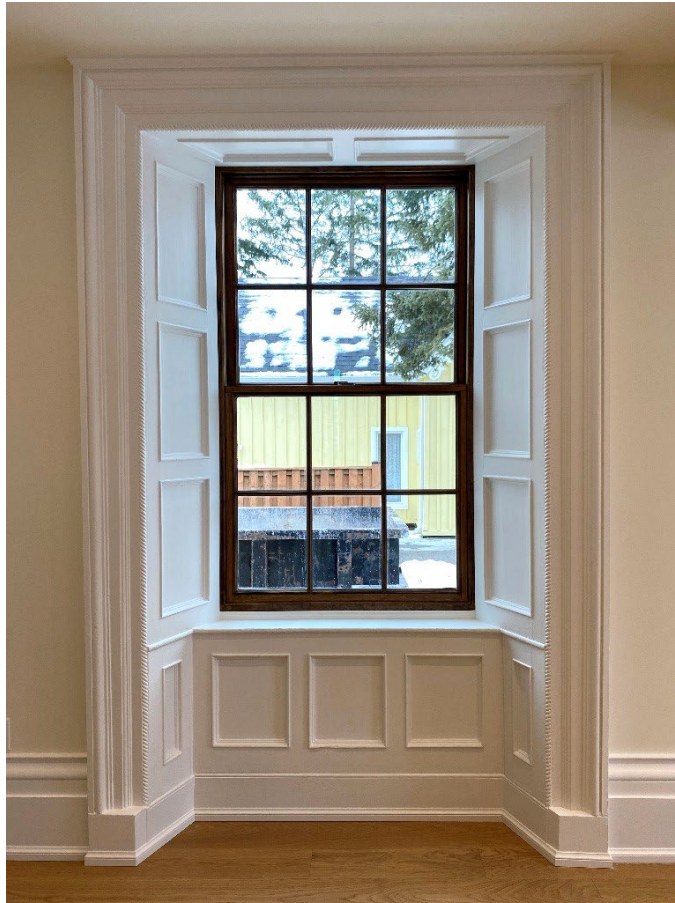
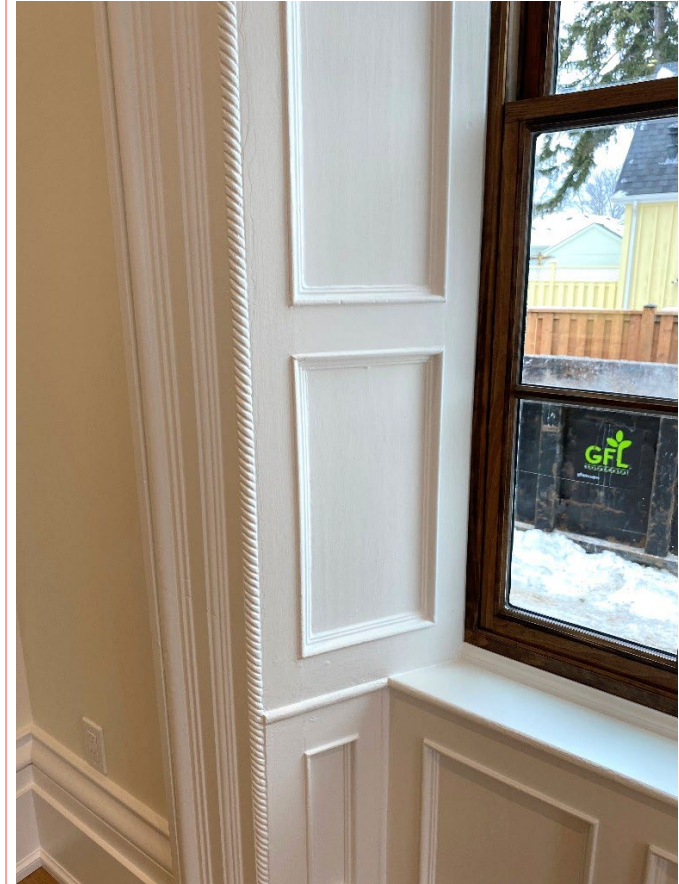
Interior, first level architraves at the central entrance and windows that include full-wall height moulding and panelling and twisted cord beading
